Recall Campaign Bulletin

Campaign No. 2019100001, October 2019

SUBJECT: Model A-Class (177 platform), CLA-Class (118 platform), and GLC-Class

Check Driver Airbag Module Locknut

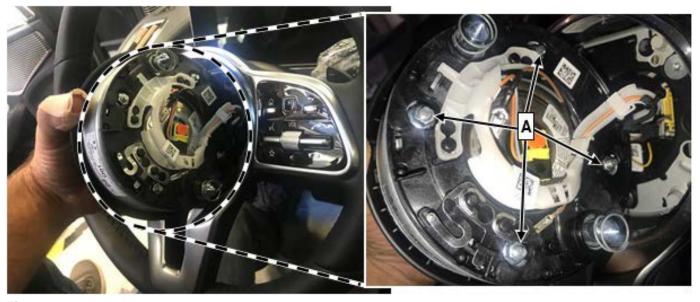
Figure 1

Daimler AG ("DAG"), the manufacturer of Mercedes-Benz vehicles, has determined that on certain Model Year ("MY") 2019-2020 A-Class (177 platform), CLA-Class (118 platform), and GLC-Class (253 platform) vehicles, the four locknuts securing the driver's side front airbag might not have been installed according to current production specification. In the event of a crash necessitating deployment of the driver's-side front airbag, the airbag module might separate from the base plate and enter the passenger compartment with high velocity. The restraint effect of the driver airbag might be impaired and increasing the risk of injury for the occupants in the event of a crash. An authorized Mercedes-Benz dealer will check the driver airbag module on the affected vehicles and replace it, if necessary.

- Remove airbag unit from steering wheel.
 - **i** Basic data for models 118; 177; 247 (AR91.60-P-0663MFA).
 - **i** Basic data for models 253; 293 (AR91.60-P-0660LW).
 - For the visual inspection of the airbag unit threaded connections, it is not necessary to disconnect the electrical connector.
- 3. Check the 4 threaded connections (A) (Fig. 1).
 - i The 4 nuts (A, Fig. 1) must be present.

- **a.** If the nuts on the driver airbag unit **are not** present: perform **Work procedure**.
- **b.** If the nuts on the driver airbag unit are present: **end task**.
- The findings from the check/test procedure must be recorded in writing on the work order.

1. Replace airbag unit.

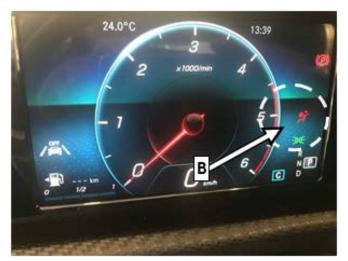
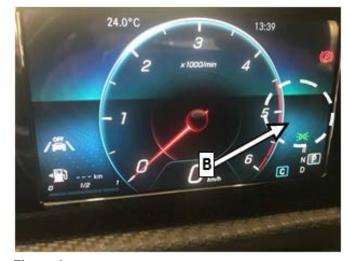
Figure 2

3. Turn the transmitter key in the electronic ignition lock to **position 1** *or* press the start button once without touching the brake pedal (ignition position 1) and check whether the airbag indicator lamp (B, Fig. 2 *or* 3) in the instrument cluster goes out permanently after a few seconds.

The SRS indicator lamp check after airbag check or airbag replacement guaranties functionality.
