TO: All U.S. Ford and Lincoln Dealers
**SUBJECT: NEW VEHICLE DEMONSTRATION / DELIVERY HOLD -
 Safety Recall 19S32**
 Certain 2020 Model Year Explorer and Police Interceptor Utility Vehicles
 with a 2.3L or 3.3L Gas Engine
 Potential Wire Harness Contact to A/C Pulley

CERTAIN 2020 MODEL YEAR EXPLORER AND POLICE INTERCEPTOR UTILITY VEHICLES WITH A 2.3L OR 3.3L GAS ENGINE

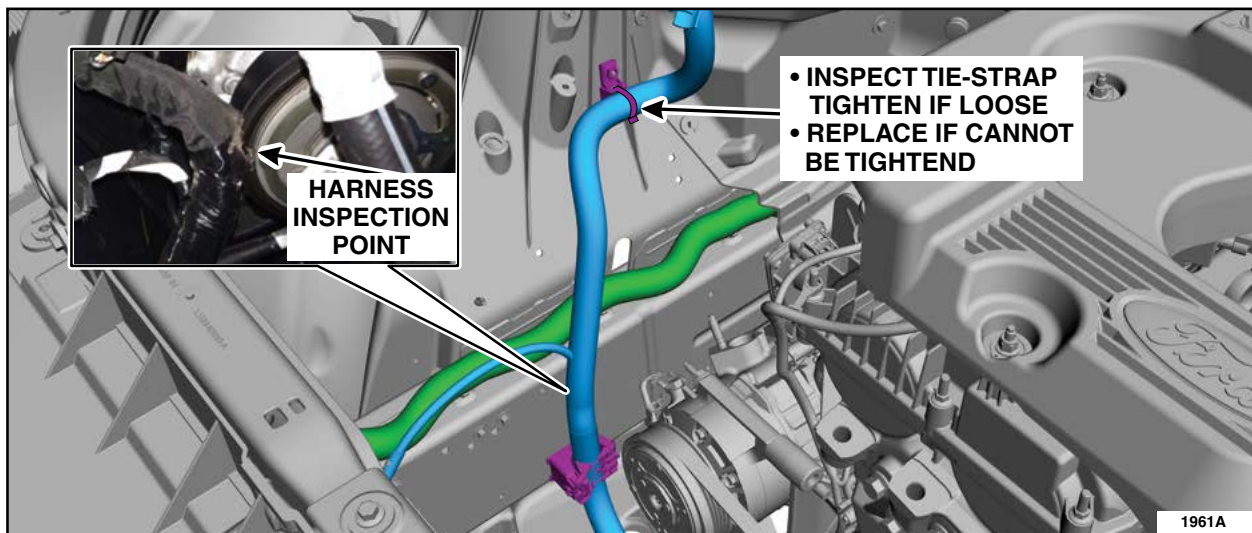
FIGURE 1

1. Inspect the battery positive cable wire harness in the areas shown for damaged and exposed wire. See Figure 1.
 - Replace the wire harness if any of the larger circuits (2/4/6 awg) have exposed copper wire strands.
 - Repair any damaged (smaller gauge) circuits in the wire harness that have exposed copper wire strands. Please follow the recommended splicing method contained in the wire diagrams section of the Workshop Manual (WSM).
2. Inspect the tie-strap located on the passenger side strut tower. Tighten the tie-strap to properly retain the harness. See Figure 1.
 - Replace the tie-strap if it cannot be tightened fully.
