SUBJECT: NEW VEHICLE DEMONSTRATION / DELIVERY HOLD - Safety Recall 19S31
Certain 2019 Model Year F-Super Duty Vehicles
Passenger Side Rear Axle Shaft Inspection

NEW VEHICLE DEMONSTRATION / DELIVERY HOLD - Safety Recall 19S31

CERTAIN 2019 MODEL YEAR F-SUPER DUTY VEHICLES — PASSENGER SIDE REAR AXLE SHAFT INSPECTION

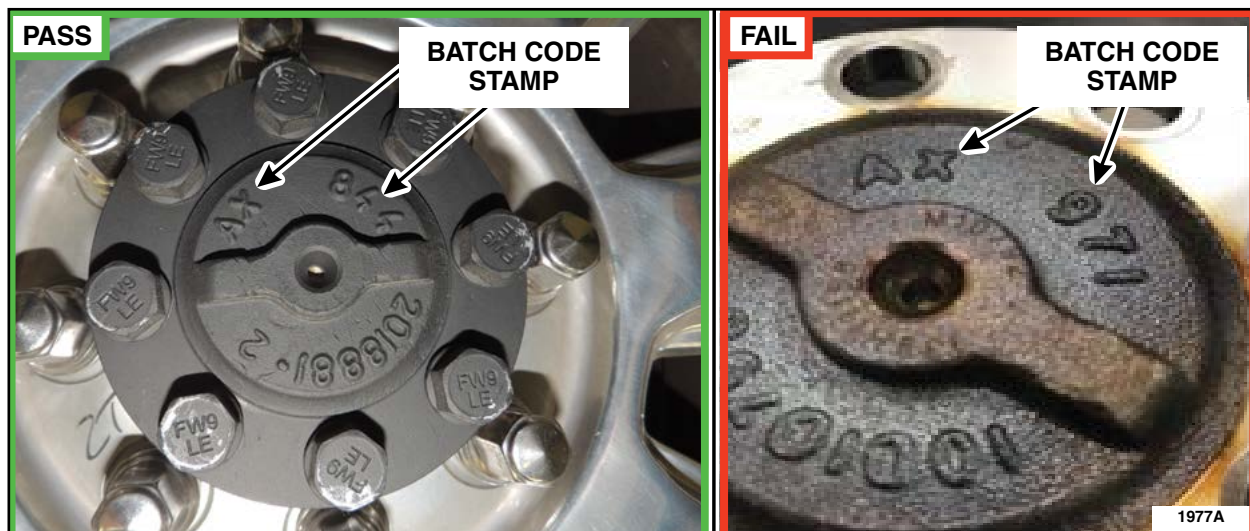
FIGURE 1

In some of the affected vehicles, the passenger side rear axle shaft is made of an incorrect material composition that does not meet Ford's torsional strength and hardness specifications. An axle shaft that does not meet Ford's specifications may fracture. This can subsequently result in a loss of motive power and the inability to hold the park function. If the parking brake is not applied, this could result in unintended vehicle movement, increasing the risk of injury or crash.

1. Remove the passenger side rear wheel center cap (if equipped).
2. Inspect the batch code stamp located on the passenger side rear axle shaft flange.
See Figure 1.

- Is the batch code stamp AX 971?

Yes - The passenger side rear axle shaft requires replacement. Proceed to Step 3.

No - No further action is required, the safety recall is complete.
