TO: Mercedes-Benz Dealer Principals, General Managers, Sales Managers, Service Managers, Parts Managers	FROM: Gregory Gunther, Department Manager, Vehicle Compliance and Analysis, Engineering Services
RE: Recall Campaign Launch Notification Fastening of Rear Door Trim Bar MY20 GLE-Class (167 platform) and GLS-Class (X167 platform)	DATE: October 25, 2019

Campaign No. 2019100011, October 2019

SUBJECT: **Model GLE-Class (167 platform) and GLS-Class (X167 platform)
Model Year 2020****Check window divider on right and left rear doors, Rework if necessary.**

Order No. P-RC-2019100011

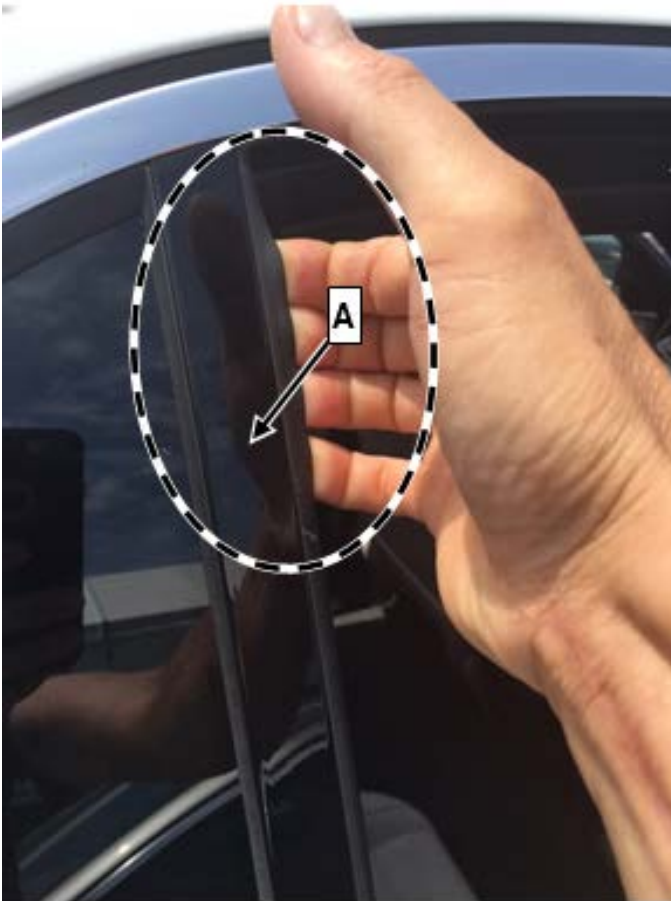
Figure 1

1. Lower side window on right and left rear door.
2. Check window divider (**A, figure 1**) on right and left for tight seating.

i To do so, grasp the window divider in the upper area by hand (**figure 1**) and support with the thumb on the fixed window (**figure 2**). After this, carefully pull the window divider to the outside with minor force.

- a. Window divider (A) detaches due to slight tractive force: Carry out work procedure.
- b. Window divider (A) does not loosen due to slight tractive force: **End measure.**

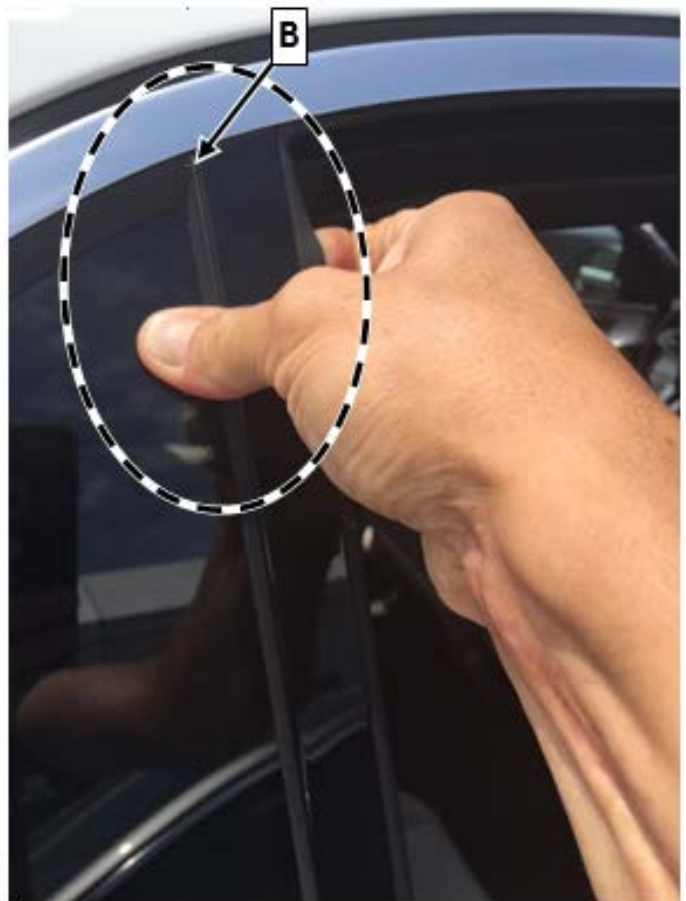
Figure 2

i The window divider should not detach due to the minor force. Ensure that there is at least a 1mm clearance between the chrome trim strip (**B, Figure 2**) and window divider (**A, Figure 2**), and that the window divider does not jam under the chrome trim strip of the window frame (**B**). If the window divider jams under the chrome strip, the test results in a false positive.
