TO: Mercedes-Benz and Freightliner Dealer Principals, General Managers, Sales Managers, Service Managers, Parts Managers	FROM: Anthony Washington, Department Manager, Regulations and Certifications
RE: Recall Campaign Notification Model 907 (Sprinter) Model Year 2019 Abutting Wedge	DATE: December 13, 2019

Campaign No. 2019120002, December 2019

SUBJECT: **Model 907 (Sprinter), Model Year 2019
Abutting Wedge**

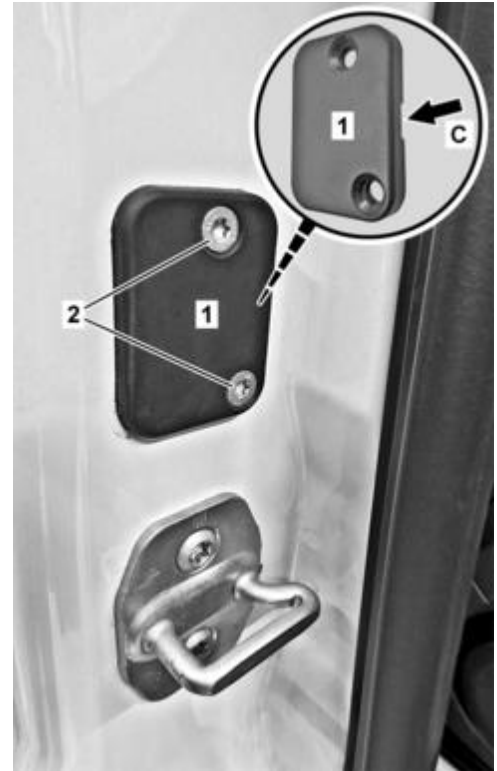
Figure 1: D72.10-A004-03

Shown on model 907.6, right side of vehicle

- 1 Closing wedge
- 2 Bolts

1	Check installation position of wedge-type stop (1) on left and right B-pillar.	<p>i</p> <p>Cutout must face toward vehicle interior (see arrow C). If the cutout (see arrow C) of the wedge-type stop (1) does not face toward the vehicle interior,</p> <p>↓</p> <p>rotate wedge-type stop (1) through 180°; to do so, continue with operation step 3. If the cutout (see arrow C) of the wedge-type stop (1) faces toward the vehicle interior,</p> <p>↓</p> <p>proceed with operation step 2.</p>	
2	Check torque of screws (2).	<p>i</p> <p>To do so, tighten screws (2) to specified torque.</p> <p>Nm Bolt, wedge-type stop to B-pillar</p> <p>If the screw (2) or rivet nut (3) turns and the torque is not reached,</p> <p>↓</p> <p>replace rivet nuts (3); to do so, continue with operation step 3. If torque is reached,</p> <p>↓</p> <p>end the measure.</p>	BA72.10-N-1011-01TS
Remove

3	Remove wedge-type stop (1).	<p>If the installation position of the wedge-type stop (1) is incorrect or the rivet nuts (3) are replaced.</p> <p>

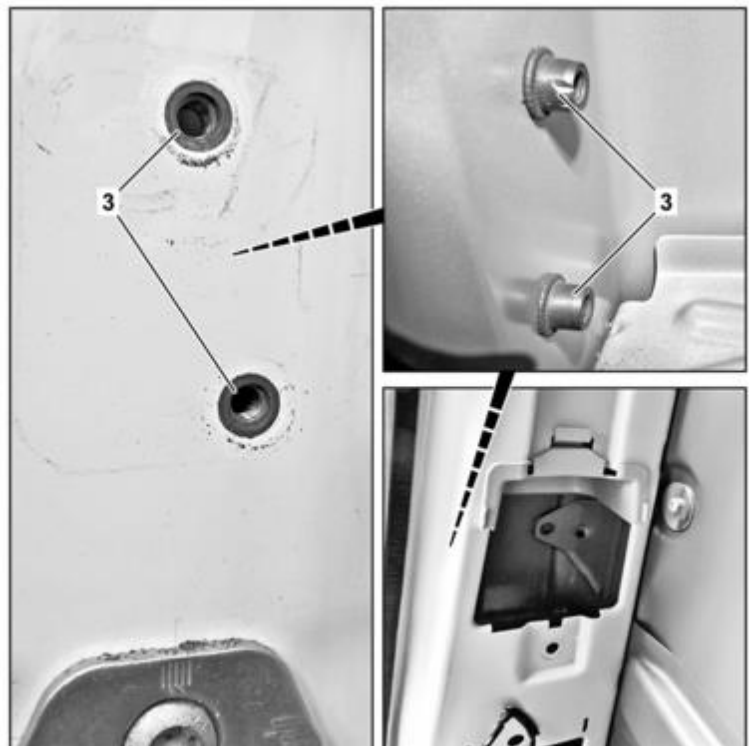
Figure 2: D72.10-A005-12

Shown on model 907.6, right side of vehicle

- 3 Rivet nuts

To do so, counterhold rivet nuts (3) using pliers through opening in respective B-pillar and remove screws (2).</p>	
6	Remove rivet nuts (3).	<p>If rivet nuts (3) are replaced.</p> <p>

Drill out using a suitable drill bit \varnothing 8.5 mm.</p>

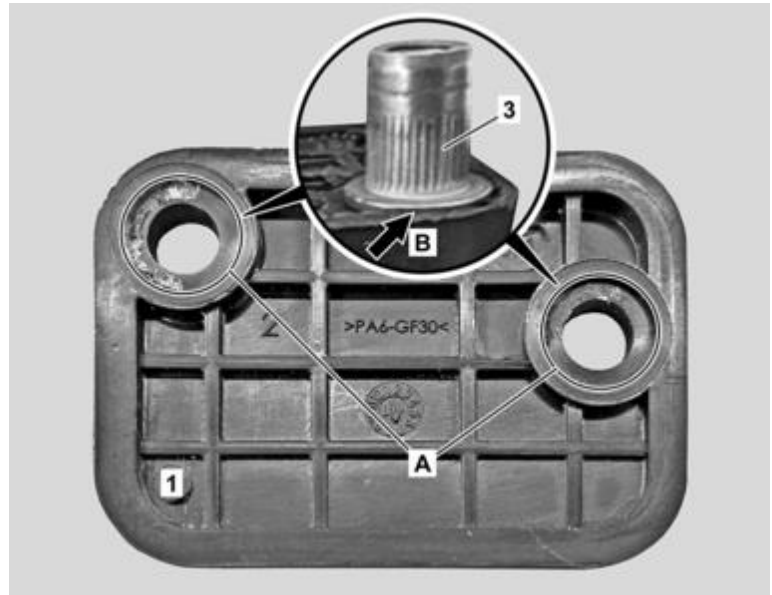
Figure 3: D72.10-A006-11

A Contact surface
 1 Closing wedge
 3 Rivet nut
