TO: Mercedes-Benz and Freightliner Dealer Principals, General Managers, Sales Managers, Service Managers, Parts Managers	FROM: Anthony Washington, Department Manager, Regulations and Certifications
RE: Recall Campaign Notification Model 907 (Sprinter) Model Year 2019 Abutting Wedge	DATE: January 15, 2020

Campaign No. :	Campaign Desc. :	<h1>Abutting Wedge</h1>
2019120002	VS3KEIL	
<p>This is to notify you of the upcoming Recall Campaign concerning the wedge-type stop on the B-pillar on approximately 153 MY19 Mercedes-Benz and Freightliner Sprinter vans. The recall campaign will be visible on the www.safercar.gov website and may generate questions from customers. All affected VINs will be flagged as "OPEN" in VMI January 16, 2020.</p>		
Background		
Issue	<p>Mercedes-Benz AG ("MBAG"), the manufacturer of both Mercedes-Benz and Freightliner vehicles, has determined that on certain Sprinter VS30 vehicles (platform 907), the wedge-type stop on the B-pillar (abutting wedge) on the driver & front passenger side may not have been installed as intended. The abutting wedge may have been mounted on holes that were drilled too large and/or incorrectly rotated. If a vehicle has an incorrectly i

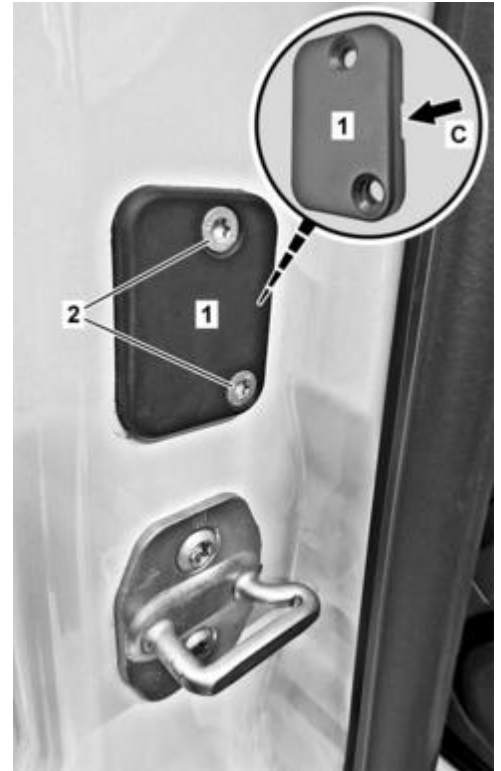
Figure 1: D72.10-A004-03

Shown on model 907.6, right side of vehicle

- 1 Closing wedge
- 2 Bolts

1	Check installation position of wedge-type stop (1) on left and right B-pillar.	<p>i Cutout must face toward vehicle interior (see arrow C). If the cutout (see arrow C) of the wedge-type stop (1) does not face toward the vehicle interior, ↓ rotate wedge-type stop (1) through 180°; to do so, continue with operation step 3. If the cutout (see arrow C) of the wedge-type stop (1) faces toward the vehicle interior, ↓ proceed with operation step 2.</p>	
2	Check torque of screws (2).	<p>i To do so, tighten screws (2) to specified torque.</p> <p>Nm Bolt, wedge-type stop to B-pillar If the screw (2) or rivet nut (3) turns and the torque is not reached, ↓ replace rivet nuts (3); to do so, continue with operation step 3. If torque is reached, ↓ end the measure.</p>	BA72.10-N-1011-01TS
Remove

3	Remove wedge-type stop (1).	<p>If the installation position of the wedge-type stop (1) is incorrect or the rivet nuts (3) are replaced.</p> <p>i</p> <p>To do this, remove screws (2). Replace screw/bolts (2). If screws (2) can be removed, ↓ continue with step 11. If screws (2) cannot be unscrewed or if rivet nuts (3) turn, ↓ continue with operation step 4.</p>	
4	Remove respective seat belt from B-pillar.	If rivet nuts (3) are replaced.	AR91.40-D-1015TS
5	Remove screws (2).	<p>If rivet nuts (3) are replaced.</p> <p>i</p> <p>Replace screw/bolts (2).</p> <p>i</p> <p>To do so, counterhold rivet nuts (3) using pliers through opening in respective B-pillar and remove screws (2).</p>	
6	Remove rivet nuts (3).	<p>If rivet nuts (3) are replaced.</p> <p>

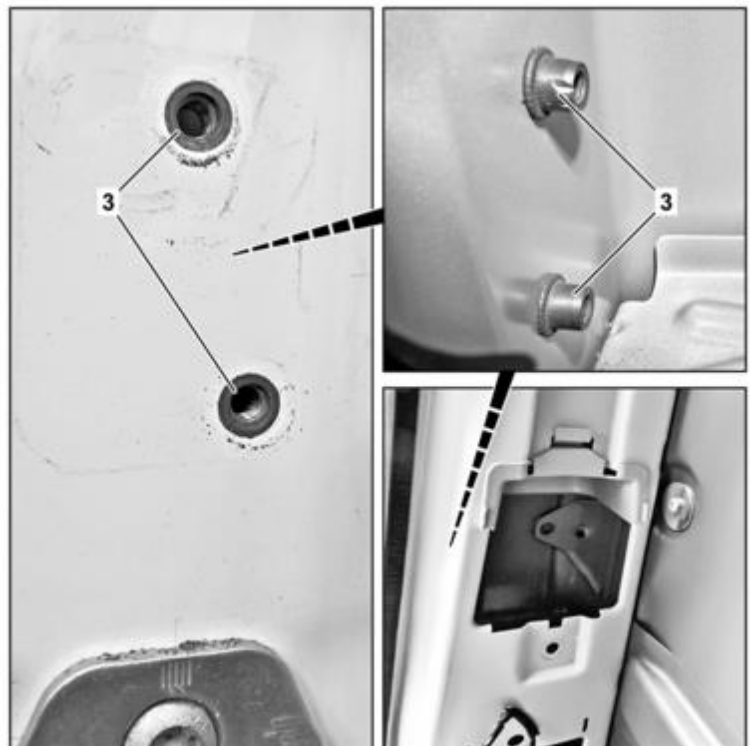
Figure 2: D72.10-A005-12

Shown on model 907.6, right side of vehicle

- 3 Rivet nuts

</p> <p>Cover up paint surface in working area. This prevents any paint damage.</p> <p>i</p> <p>Drill out using a suitable drill bit \varnothing 8.5 mm.</p>

7	Remove drill chips and residue of rivet nuts (3).	<p>If rivet nuts (3) are replaced.</p> <p>i The drill chips and residue of rivet nuts (3) can be reached through an opening in respective B-pillar.</p> <p>i Commercially available devices/tools Wet and dry vacuum cleaner</p>	
8	Apply zinc dust paint around bores.	<p>If rivet nuts (3) are replaced.</p> <p>1K-zinc dust paint</p>	BR00.45-Z-1056-07A
Install			
9	Process wedge-type stop (1).	<p>If rivet nuts (3) were replaced.</p> <p>i The head of the rivet nut (3) must be flush with the outer edge of the wedge-type stop (1) (see arrow B). Process contact surfaces (A) of wedge-type stop (1) using a suitable tool until the wedge-type stop (1) lies flush with the B-pillar.</p>	
10	Install new rivet nuts (3).	<p>If rivet nuts (3) were replaced.</p> <p>i Commercially available devices/tools Rivet nut pliers</p>	
11	Install wedge-type stop (1).	<p>i Cutout must face toward vehicle interior (see arrow C).</p> <p>i To do so, position wedge-type stops (1) on rivet nuts (3), position new screws (2) and tighten.</p> <p>Nm Bolt, wedge-type stop to B-pillar</p>	BA72.10-N-1011-01TS

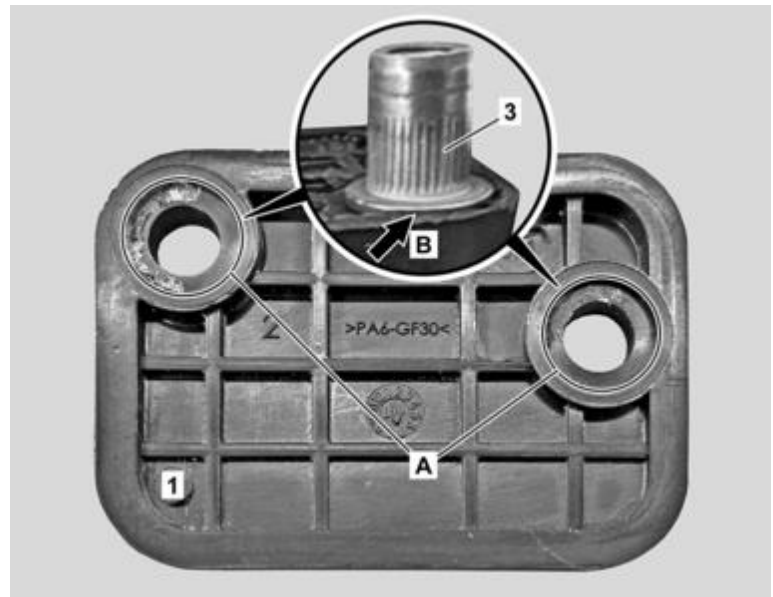
Figure 3: D72.10-A006-11

A Contact surface
 1 Closing wedge
 3 Rivet nut
