Federal Recall Information

19PBE

Peterbilt

Safety Recall – Back of Sleeper Reflective Conspicuity Tape Location

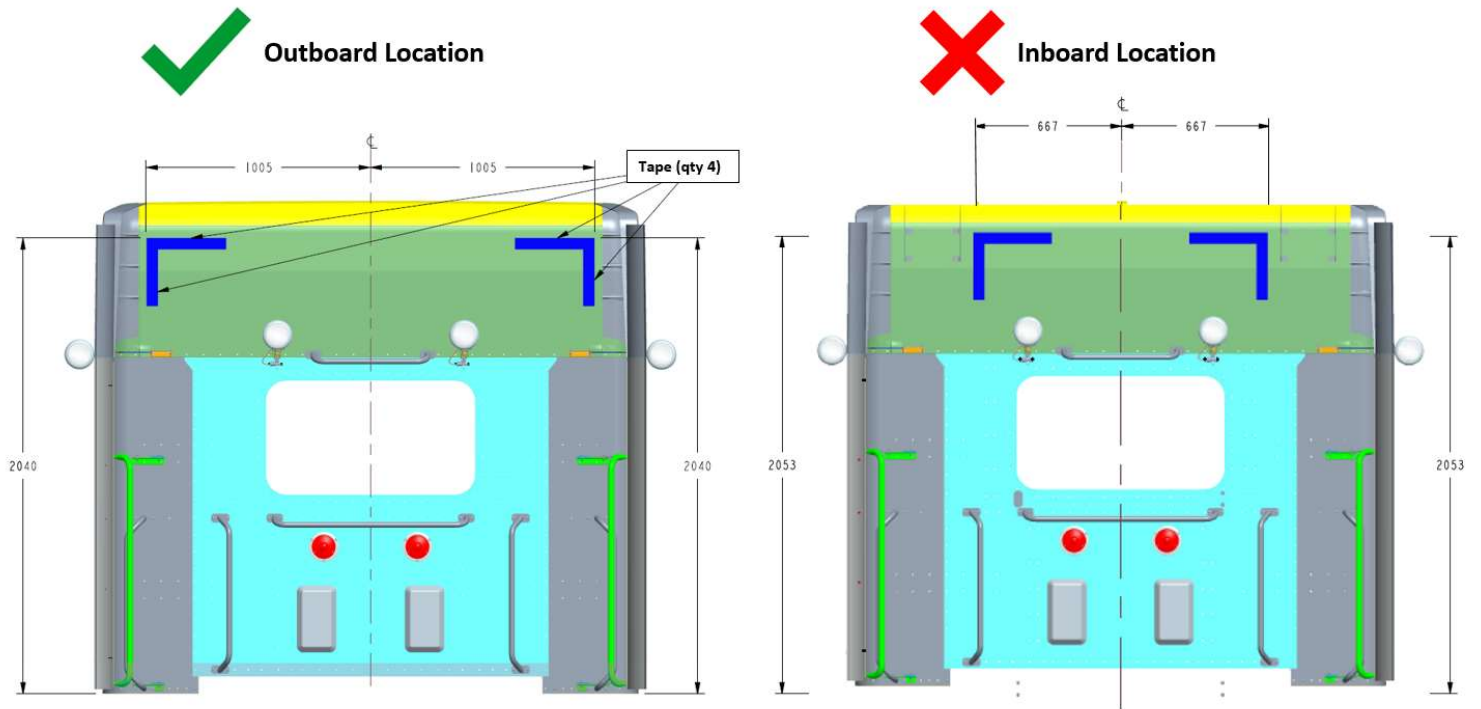
Peterbilt Motors Company has determined that a regulatory non-compliance, may exist in certain model 579 vehicles manufactured between 8/26/2019 and 9/12/2019. On certain trucks, the reflective conspicuity tape on the back wall of the sleeper box was installed in incorrect locations. FMVSS 108 Section S8 2.4.2 regulations require the conspicuity tape to be placed in specific areas. A truck that does not have properly placed conspicuity tape may be less visible to others and could create an increased risk of a crash. Vehicles operating without a trailer may be cited for incorrect tape location and fail an annual truck inspection.

1. Refer to Figure 1 and inspect the location of the Reflective Conspicuity Tape.
2. If the tape is located in the inboard location, continue to the next step. Removal of the tape in the inboard location is not required. If the tape is removed, use an adhesive cleaner that is appropriate for use on painted surfaces to remove the tape residue.
3. Clean the new installation surface and install the new tape in the outboard location as shown in Figure 1.
