SAFETY BULLETIN

Communication #: T-19-01

Model Year(s): 2015-2019

SUBJECT: BATTERY FUSE BLOCK INSPECTION / CHASSIS FUSE RELOCATION

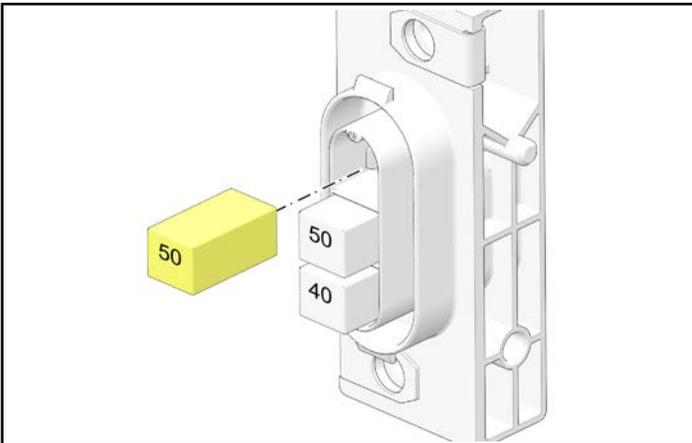
2. Remove the 50A Chassis (top) fuse and discard.

This fuse will not be reused.

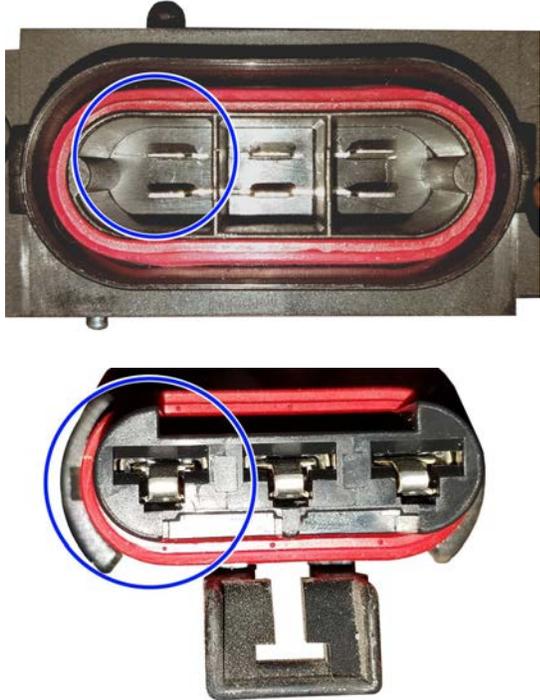
DAMAGE IS NOT PRESENT	DAMAGE IS PRESENT
<p>Battery Fuse Block interior or Electrical Connector</p>

Damage = Any sign of heat damage in the Battery Fuse Block interior or to the electrical connector.

- If damage **IS** present, take pictures of the damage and submit an ASK Polaris case for further instructions.
US/CAN: Submit an Ask Polaris Service & Warranty Question> All Vehicle Diagnostic case.
INT'L: Contact your Country Service Department.
- If damage is **NOT** present, proceed to the INSTALLATION section of this bulletin.

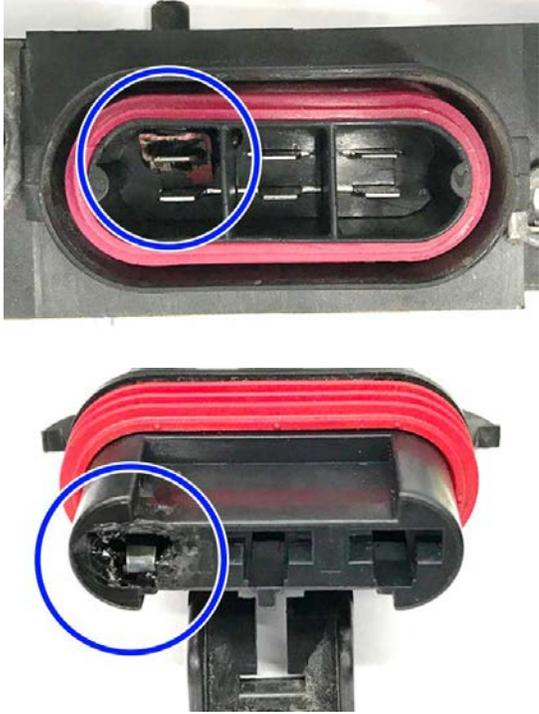
<p>Battery Fuse Block interior or Electrical Connector</p>

<p>Do not allow the machine to be operated until you have repaired the machine as directed by Technical Service. If damage is present, do not file a warranty claim until directed by Polaris Technical Service.</p>
