January 31, 2019

SUBJECT: **NEW VEHICLE DEMONSTRATION / DELIVERY HOLD -
 Safety Recall 19S43 – Supplement #2**
 Certain 2019 Model Year Ranger Vehicles
 Rear Tail Lamps

CERTAIN 2019 MODEL YEAR RANGER VEHICLES — REAR TAIL LAMP WIRING

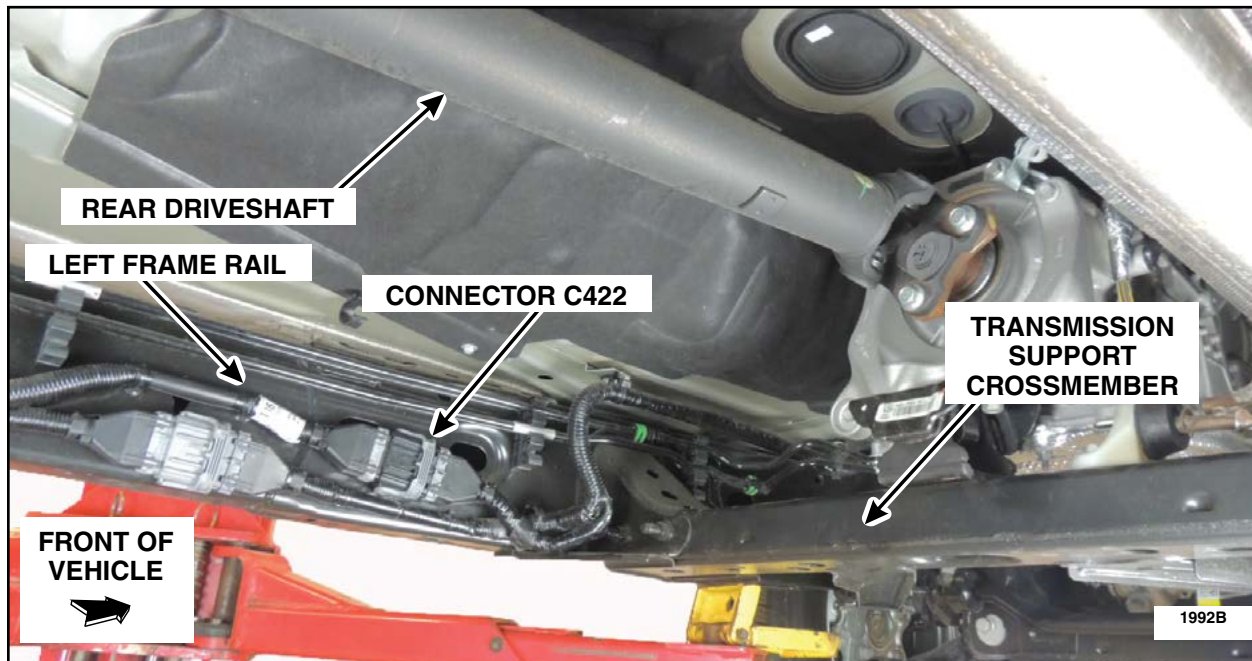
FIGURE 3

The C422 connector is a 34-pin inline connector and is located on the 14290 to 14405 harness mounted to the left frame rail around mid-vehicle.

3. Locate connector C422, inside the left frame rail just rearward of the transmission support crossmember. See Figure 3.
