David J. Johnson
 Director
 Service Engineering Operations
 Ford Customer Service Division

November 22, 2019

**SUBJECT: NEW VEHICLE DEMONSTRATION / DELIVERY HOLD -
 Safety Recall 19S43**
 Certain 2019 Model Year Ranger Vehicles
 Rear Tail Lamps

CERTAIN 2019 MODEL YEAR RANGER — REAR TAIL LAMP WIRING

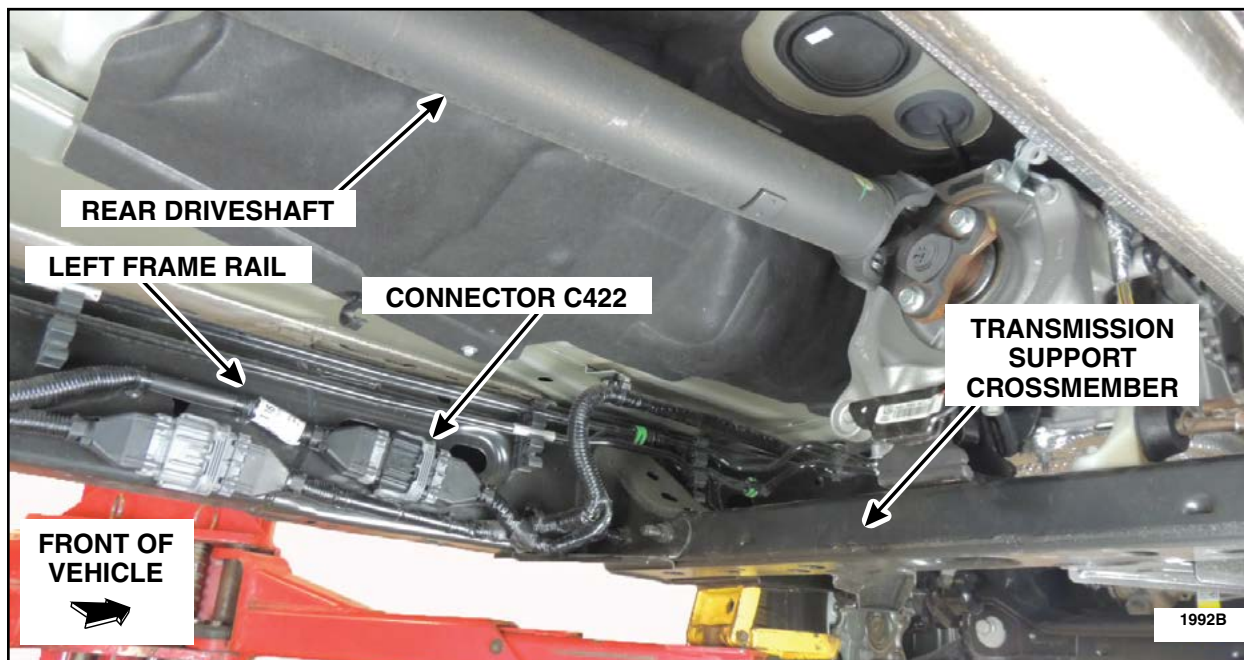
FIGURE 3

3. Locate connector C422, inside the left frame rail just rearward of the transmission support crossmember. See Figure 3.

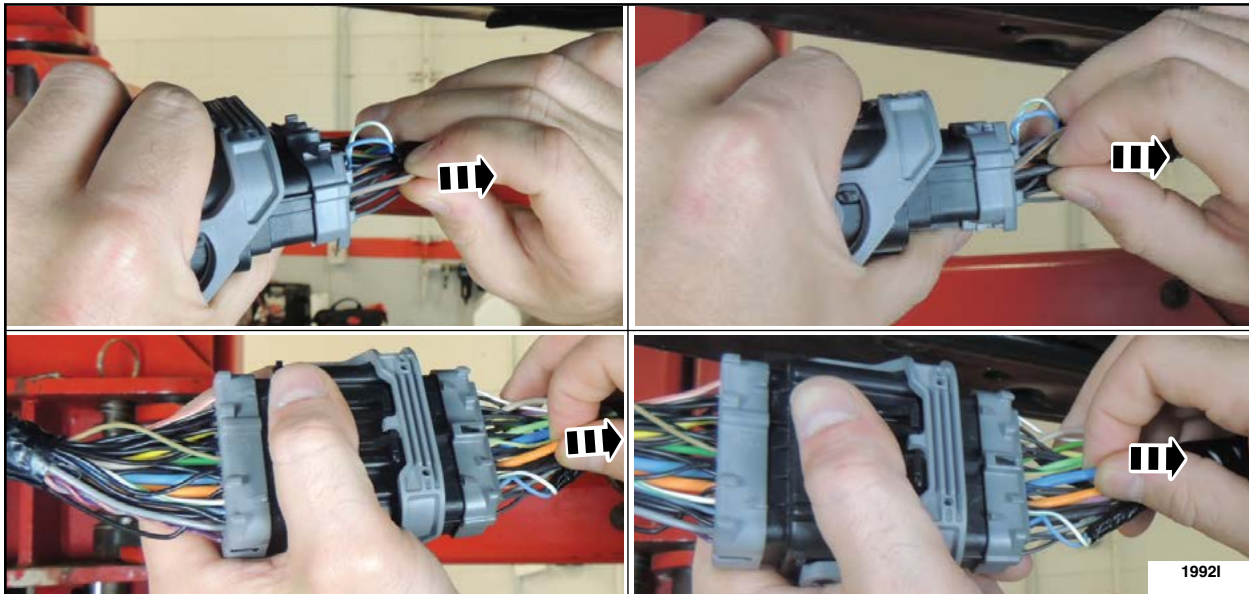
FIGURE 13

13. At connector C422, using your fingers pull on the remaining wires in the center row of terminals wires (cavities 14-19 and 21) on both male and female connector sides, checking for any terminals that may be push out of the connector hard shell. See Figures 11, 12 and 13.

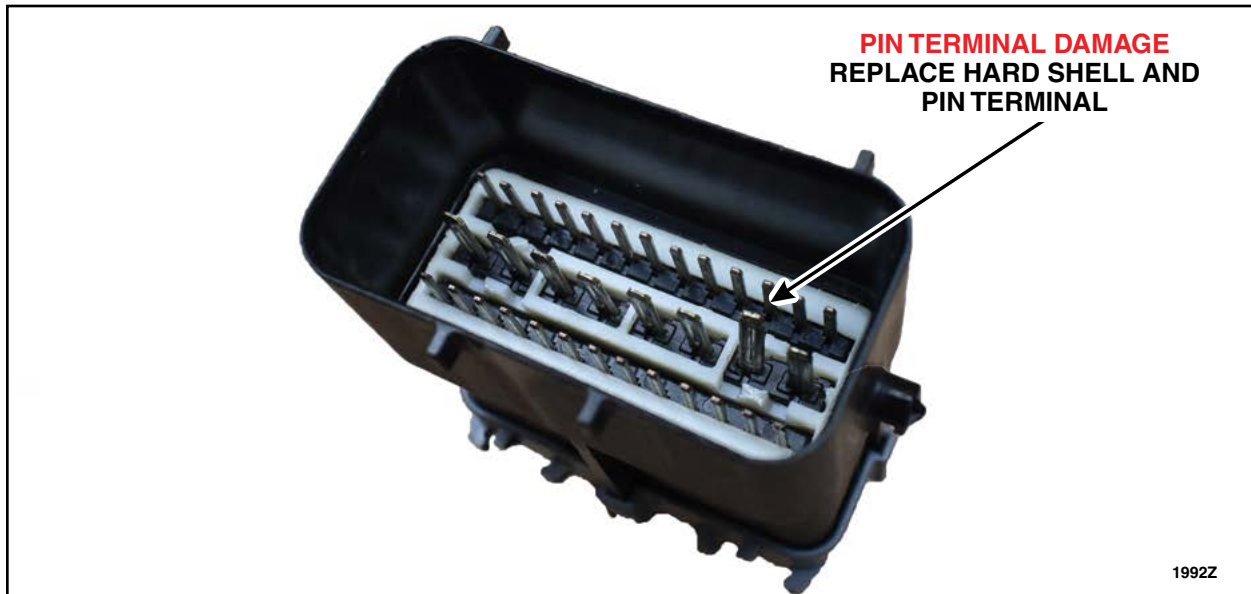
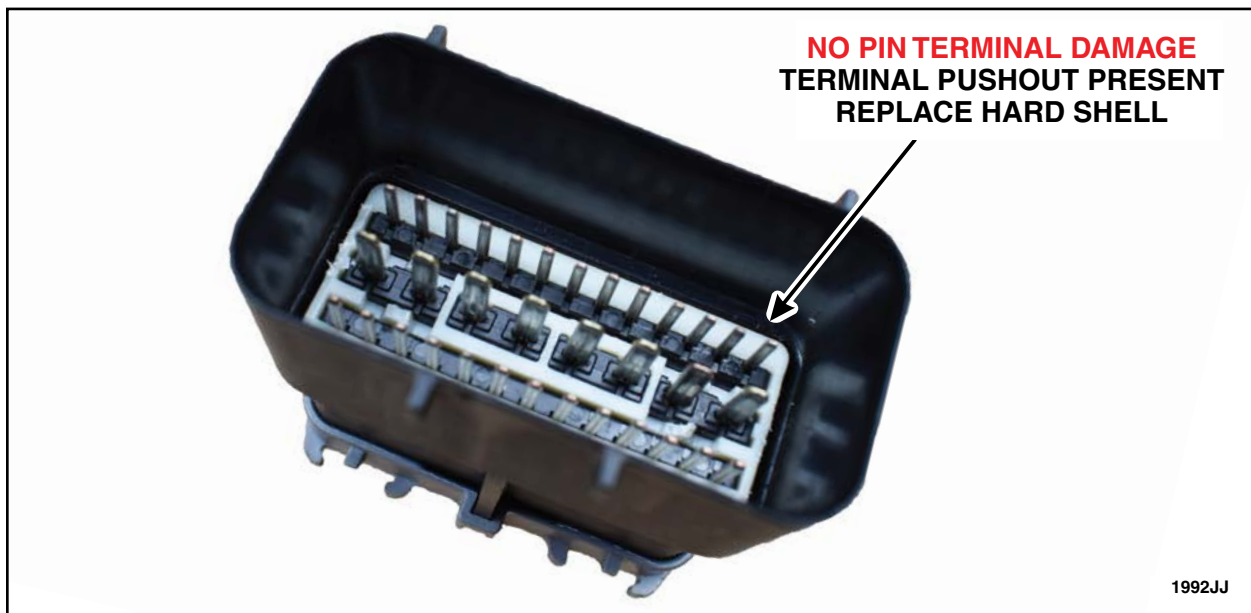
16. Inspect all of the wire terminal(s) on both connectors, and complete connector and terminal replacement as required. See Figures 16 and 17
- Replace the connector hard shell on the side(s) the pushed out terminal(s) were found. Refer to C422 Male and Female Side - Pigtail Connector Depinning Procedure.
 - Replace any damaged pin terminals that are found on either connector. Refer to C422 Male or Female Terminal Replacement Procedure.

NOTE: Only replace the connector hard shell and/or a damaged pin terminal on the side the pushed out and/or damaged terminal(s) were found.
