David J. Johnson  
 Director  
 Service Engineering Operations  
 Ford Customer Service Division

**SUBJECT:** **Safety Recall 19S54 – Supplement #1**

Certain 2006-2010 Model Year Fusion/Milan/MKZ/Zephyr Vehicles Equipped with Anti-Lock Brake Systems  
 DOT 3 Brake Fluid and Anti-Lock Brake System Function

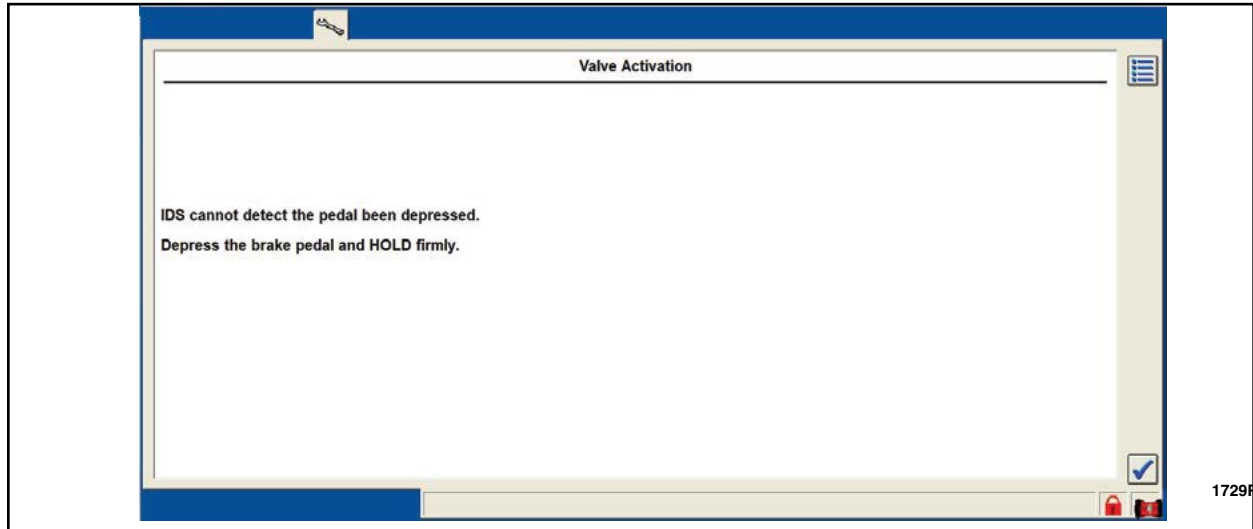
**FIGURE 6**

**NOTE:** Brake pedal must be depressed when prompted to complete the IDS routine, **if brake pedal is not depressed** you will receive a message prompting you to do so. See Figure 6.

**NOTE:** If brake pedal is depressed properly, Figure 6 **will not** apply.

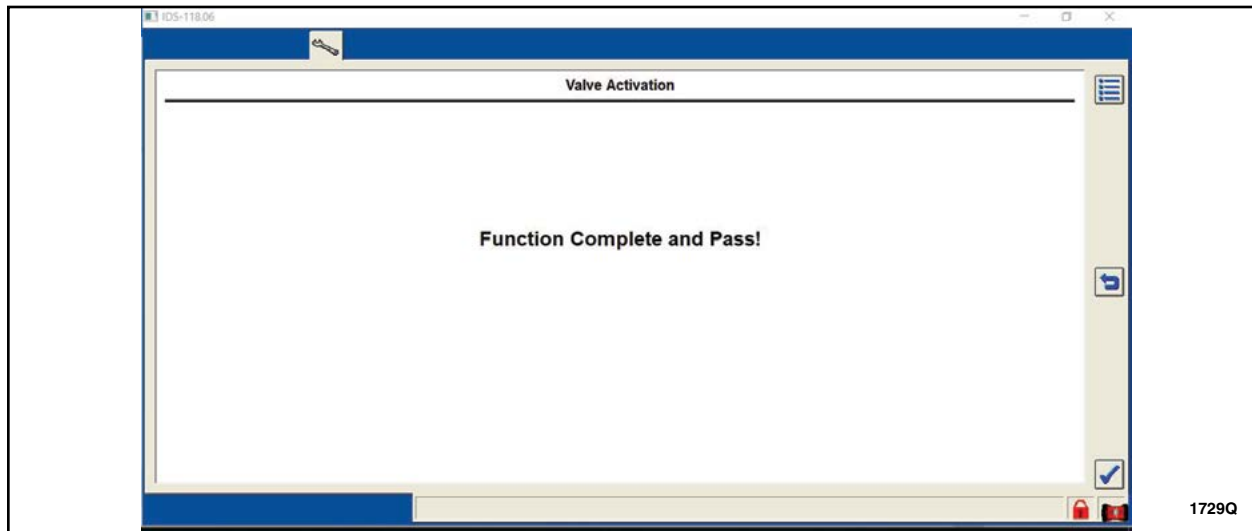
**FIGURE 10**

**NOTE:** At the end of the IDS routine, after the activation of the valves has completed a total number of four times, you will receive one of the two possible screens shown below determining if the IDS routine has passed or failed. See Figures 10 and 11.

**NOTE:** If the IDS routine ends with a Function Complete and Pass screen, See Figure 10 the brake system will need to have the DOT 3 brake fluid removed and replaced with DOT 4.

HCU Passes inspection - Proceed to Valve Activation PASSES IDS Routine, on Page 9.  
HCU Replacement Not Required.

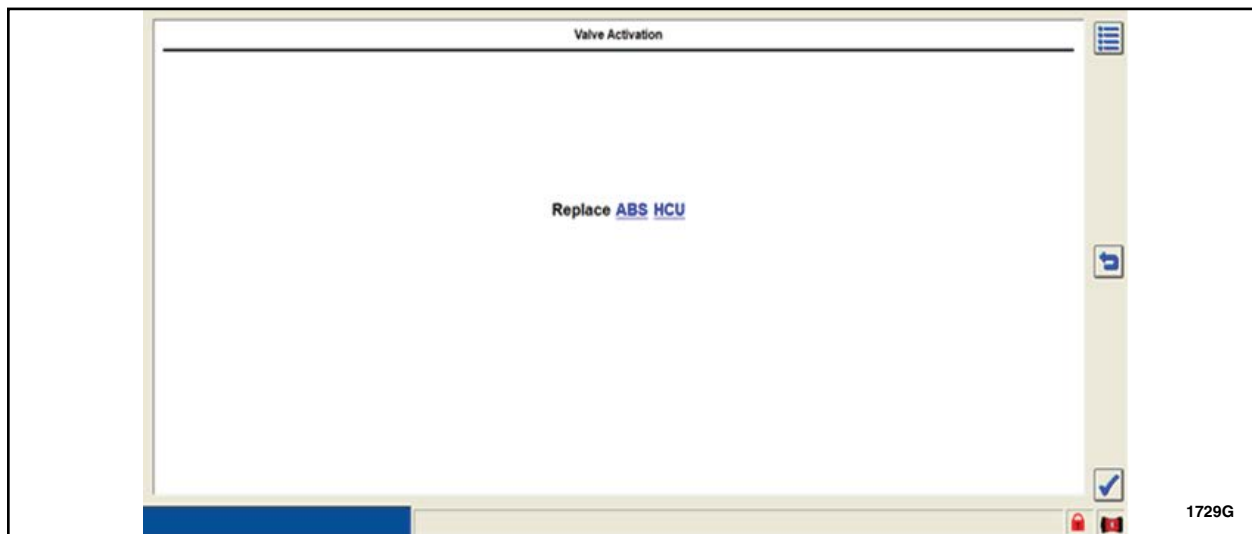
**FIGURE 11**

**NOTE:** If the IDS routine ends with a Replace ABS HCU screen, See Figure 11. Documents will be required to be submitted to the SSSC prior to HCU Replacement.

HCU DOES NOT PASS inspection - Proceed to Valve Activation FAILS IDS Routine, on Page 14.  
This procedure will include the HCU Replacement procedure,  
and Brake Fluid Change Procedure.
