David J. Johnson
Director
Service Engineering Operations
Ford Customer Service Division

SUBJECT: Safety Recall 19S54

Certain 2006-2010 Model Year Fusion/Milan/MKZ/Zephyr Vehicles Equipped with Anti-Lock Brake Systems
DOT 3 Brake Fluid and Anti-Lock Brake System Function

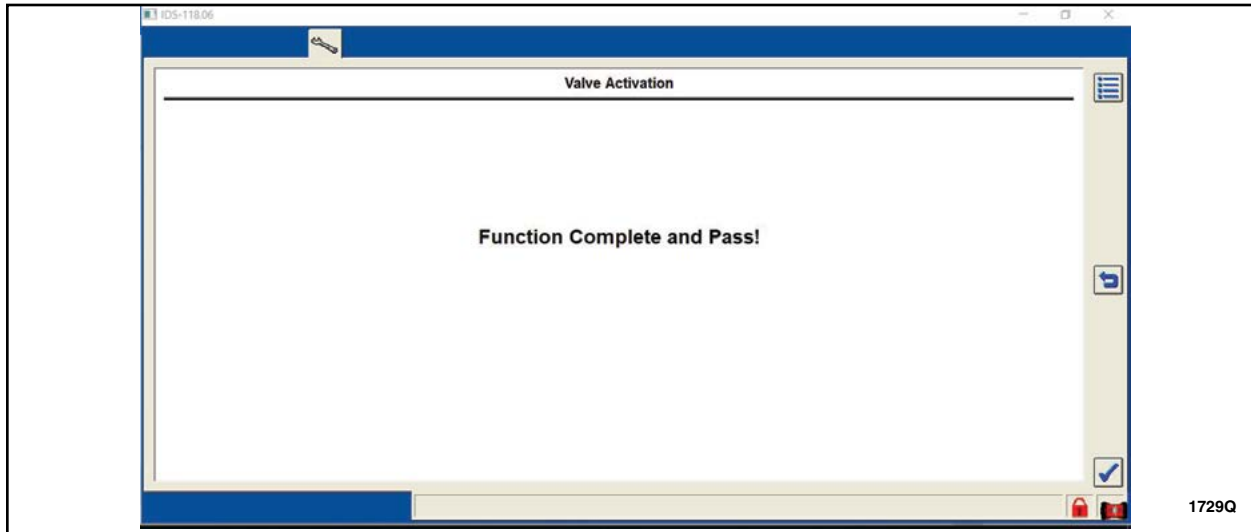
FIGURE 10

NOTE: If the IDS routine ends with a Function Complete and Pass screen, See Figure 10 the brake system will need to have the DOT 3 brake fluid removed and replaced with DOT 4.

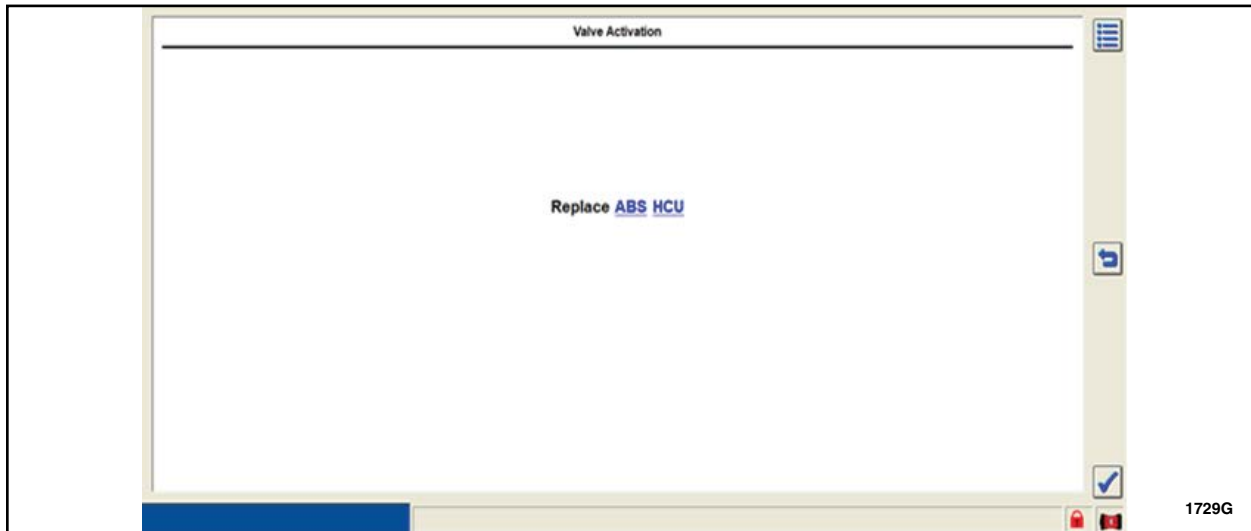
FIGURE 11

NOTE: If the IDS routine ends with a Replace ABS HCU screen, See Figure 11. Documents will be required to be submitted to the SSSC prior to HCU Replacement.

2. Proceed to HCU Replacement, after approval is given by the SSSC.
