David J. Johnson
 Director
 Service Engineering Operations
 Ford Customer Service Division

May 21, 2021

SUBJECT: Safety Recall 19S54 – Supplement #2
 Certain 2006-2010 Model Year Fusion/Milan/MKZ/Zephyr Vehicles Equipped with Anti-Lock Brake Systems
 DOT 3 Brake Fluid and Anti-Lock Brake System Function

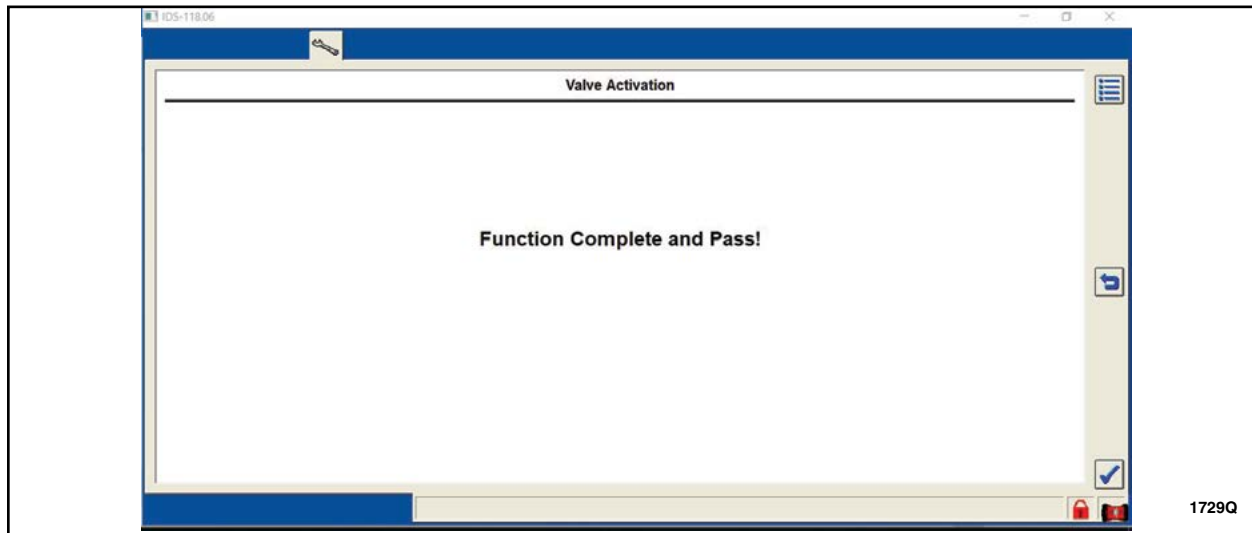
FIGURE 10

NEW ! NOTE: At the end of the IDS routine, after the activation of the valves has completed a total number of four times, you will receive one of the two possible screens shown below determining if the IDS routine has passed or failed. **The activation of the valves four times is completed within the IDS service function. Do NOT repeat the IDS Valve Activation routine multiple times - this is recorded in the IDS log file. SSSC contacts with multiple pass or fail results will not be approved, additional information will be requested.** See Figures 10 and 11.

NOTE: If the IDS routine ends with a Function Complete and Pass screen, See Figure 10 the brake system will need to have the DOT 3 brake fluid removed and replaced with DOT 4.

HCU Passes inspection - Proceed to Valve Activation PASSES IDS Routine, on Page 9.
HCU Replacement Not Required.

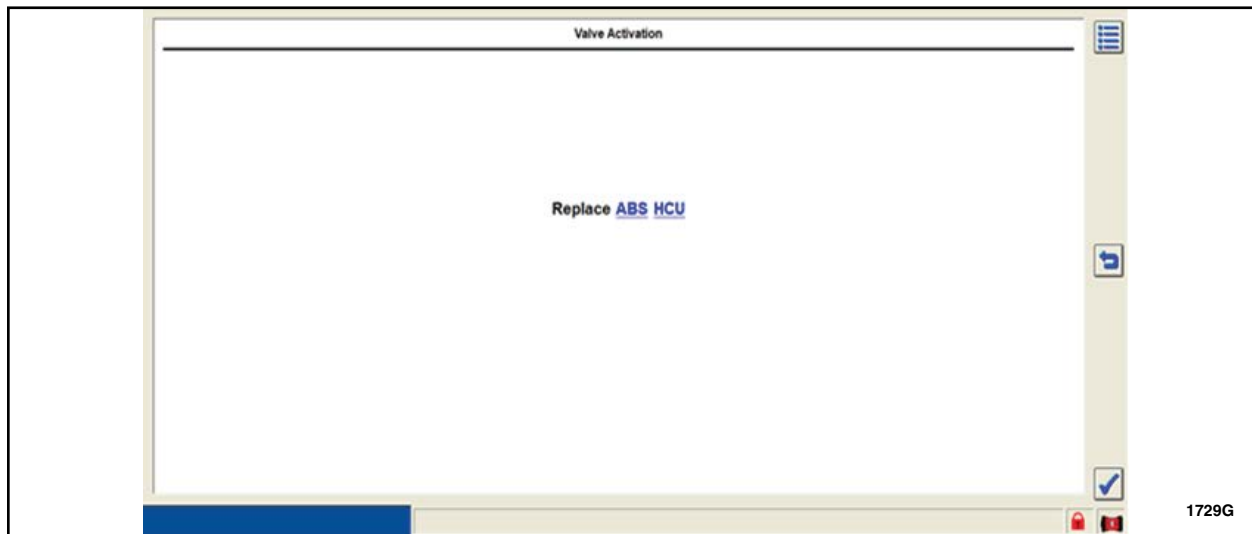
FIGURE 11

NOTE: If the IDS routine ends with a Replace ABS HCU screen, See Figure 11. Documents will be required to be submitted to the SSSC prior to HCU Replacement.

HCU DOES NOT PASS inspection - Proceed to Valve Activation FAILS IDS Routine, on Page 14.
This procedure will include the HCU Replacement procedure,
and Brake Fluid Change Procedure.
