Federal Recall Information

19PBF

Certain Model 520 vehicles with Right-Hand Standup (RHSU) configuration may have improperly supported steering assist bracket.

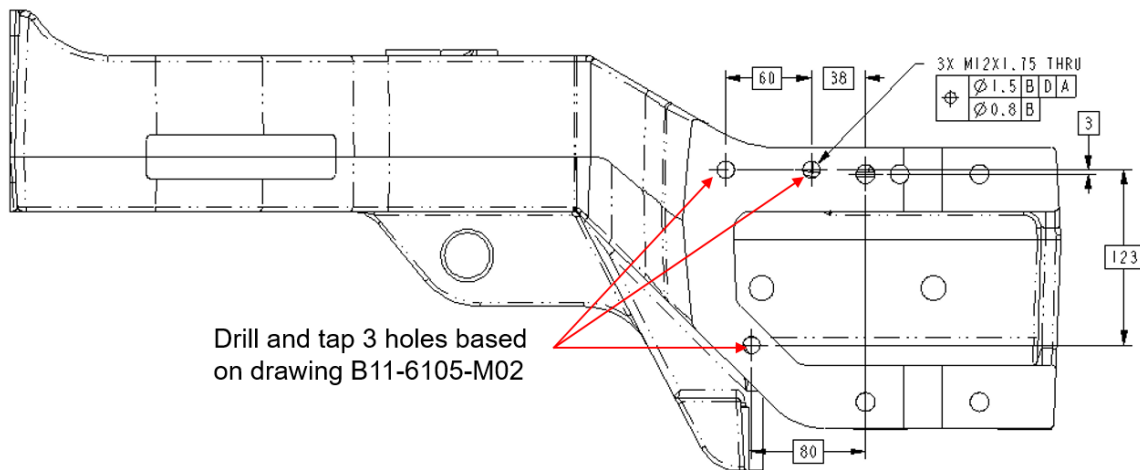
An improperly supported steering gear assist cylinder bracket may break and cause damage to surrounding components and/or lock up the steering, increasing the risk of a crash.

1. Inspect the steering gear assist bracket to ensure it is mounted with all 5 bolts. If all 5 bolts are installed. No further action is required.
2. Replace the steering gear bracket, drill and tap 3 holes per drawing B11-6105-M02R and mount the new steering gear assist bracket to the spring bracket with 5 new bolts and washers. See image below.

1. Drill – 10.3mm or 13/32 drill
2. Tap – M12 X 1.75
