TO: Mercedes-Benz Dealer Principals, General Managers, Sales Managers, Service Managers, Parts Managers	FROM: Gregory Gunther, Department Manager, Vehicle Compliance and Analysis, Engineering Services
RE: Recall Campaign Launch Notification Check Sliding Roof Bonding – Phase 1 MY06-07 Various Models	DATE: June 29, 2020

Campaign No. 2020040011, June 2020

SUBJECT: **Models C-Class, CLK-Class, E-Class, and CLS-Class (203, 209, 211, and 219 platform)**
Model Years 2006-2007
Sliding Roof Bonding - Phase 1

Order No. P-RC-2020040011

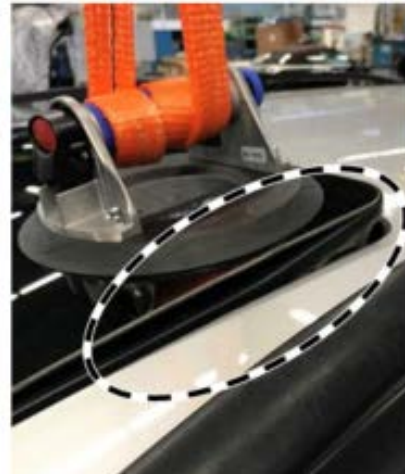
- i** The sliding roof panel is lifted out of the roof frame noticeably at the rear test positions 1 and 5 (**figure 4**).
- i** If the sliding roof panel detaches from the padding of the tilting/sliding roof frame at one of the test positions (see **figure 5**), the sliding roof panel must be replaced.

Figure 5 (**NOT OK**)

- C.** If the sliding roof panel detaches from the padding: Carry out **work procedure**.
- D.** If the sliding roof panel does **not** detach from the padding: **End measure**.

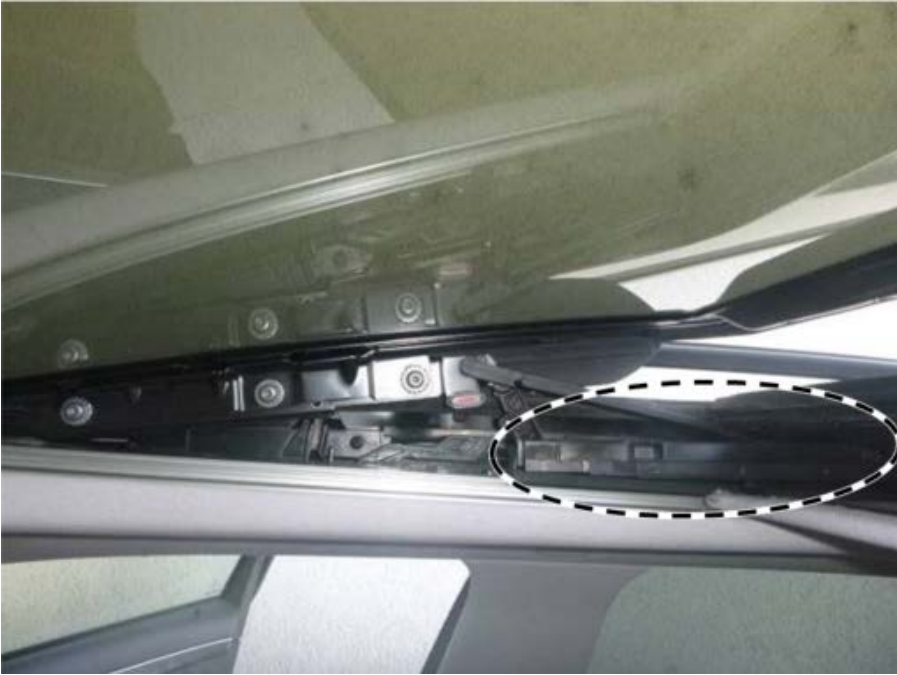
Figure 6

i The accordion boot **need** not be removed completely. It is sufficient to slide it back (**figure 6**).

1. Replace sliding sunroof.
