CAPCO USA, Inc.

IMPORTANT SAFETY RECALL NOTICE

NHTSA Recall No. 19E054

October 2019

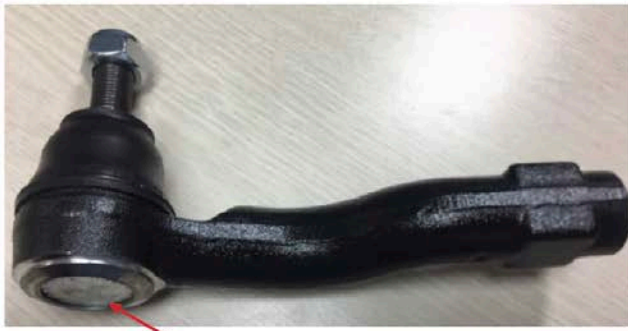
Location Of Date Code and Brand CTR

CAPCO is recalling all of the Outer Tie Rods bearing the CTR logo with any date code shown in the table above. The CTR logo and date code of your Outer Tie Rod can be located on the tie rod end. The vehicle must be mechanically lifted under the supervision of a skilled mechanic in order to see the tie rod end.

- If you believe you own a vehicle equipped with an affected Outer Tie Rod, please contact our customer service center at 1-877-597-9588 and provide them with the appropriate owner information to get your affected Outer Tie Rod inspected and replaced **FREE OF CHARGE**. If you have already incurred costs to remedy the affected Outer Tie Rod before receiving this notice, please call our customer service center to see if you are eligible for reimbursement.

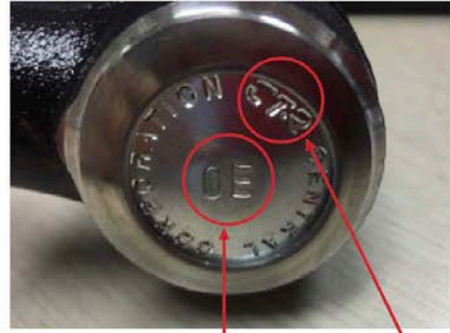
Manufacturing Date Code

CTR Logo

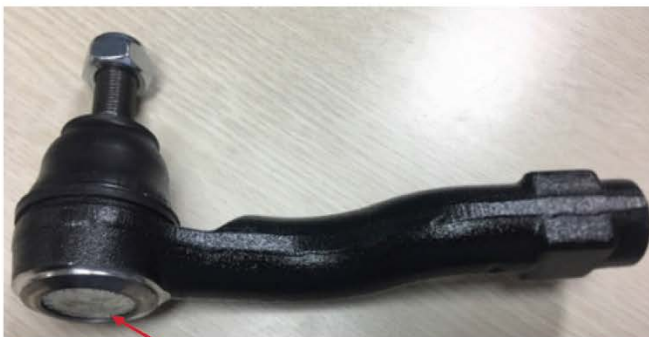
Ubicación del código de fecha y la marca CTR

CAPCO está retirando todas las terminales exteriores que lleven el logotipo CTR con cualquier código de fecha que se muestra en la tabla anterior. El logotipo CTR y el código de fecha de terminal exterior se pueden encontrar en el extremo de la terminal. El vehículo debe levantarse mecánicamente bajo la supervisión de un mecánico calificado para ver el extremo de la terminal exterior.

- Si usted cree que posee un vehículo equipado con una terminal exterior afectada, póngase en contacto con nuestro centro de servicio al cliente al 1-877-597-9588 y proporcione la información del propietario adecuada para obtener su terminal exterior inspeccionada y reemplazada **LIBRE DE CARGO**. Si ya ha incurrido gastos para remediar la terminal exterior afectada antes de recibir este aviso, llame a nuestro centro de servicio al cliente para ver si es elegible para un reembolso.

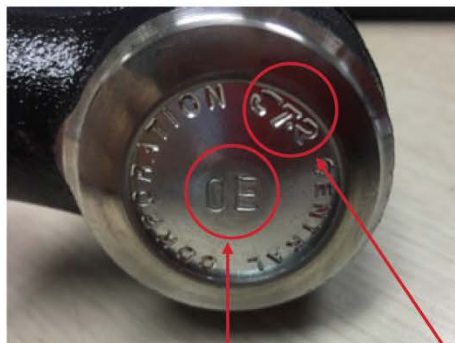
Código de fecha de fabricación

CTR Logo
