IMPORTANT SAFETY RECALL

NHTSA Safety Recall No. 19V-508

Customer Service Notice

Rotation Bearing Cap Screw Inspection

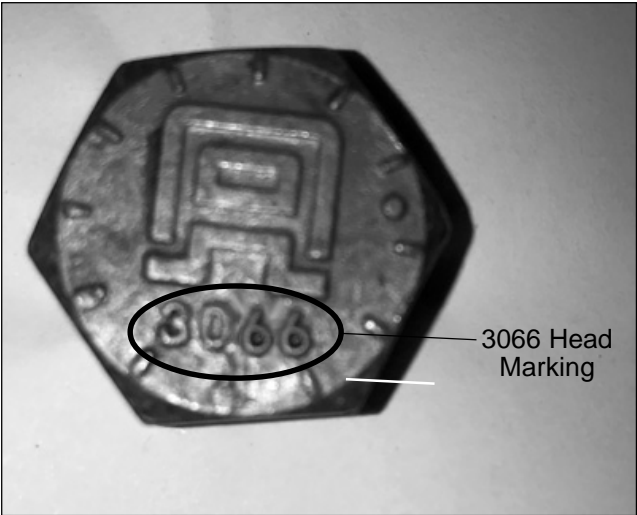
Figure 1 — Cap Screw Head Marking

Altec has received reports of isolated failures of the heads on some of the cap screws on the affected units. Investigation of the problem has found that the fasteners in a specific lot were not manufactured to the Altec fastener coating specification. The insufficient coating may lead to hydrogen embrittlement which could cause the cap screw head to fail prematurely. Failing rotation bearing cap screws can cause uncontrolled movement. **Death or serious injury can result from uncontrolled movement.**

- Perform a torque check on both the inner and outer races of the turntable rotation bearing cap screws using the Annual Torque Inspection Procedure in the Maintenance Manual.
- If any cap screws are broken, remove the unit from service and replace all of the cap screws in that rotation bearing race.
- Look for the lot number embossed on the head of each cap screw. Record the head marking on the inspection form at the end of the CSN.
- If any cap screw is marked with 3066 on the head of the fastener (refer to Figure 1), replace the cap screws in that race no later than 30 days after the inspection.
- If the fasteners are not marked with 3066 and are not broken, the inspection is completed and the unit can be returned to service and normal torque inspections can be resumed.
- Complete the inspection form at the end of this CSN and return it to Altec.
