September 2019

Dealer Service Instructions for:

Equipment Safety Recall VA4 / NHTSA 19E-062 Passenger Airbag Module

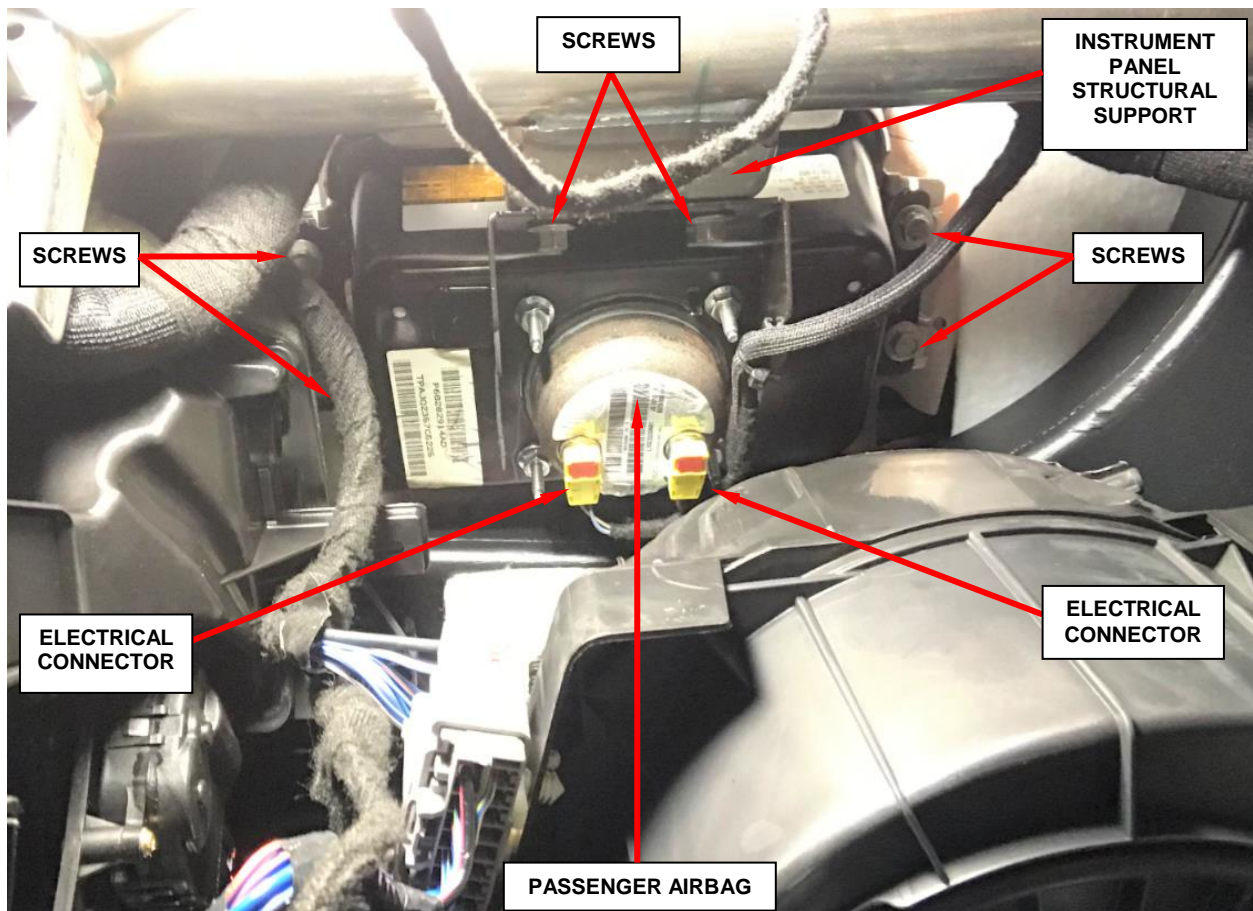
Figure 6 – Passenger Airbag

FCA US has decided that a defect, which relates to motor vehicle safety, exists in certain Passenger Airbags (PABs). Some PABs, part number 68335088AA, intended for 2019 Model Year (LD) Dodge Charger vehicles, were shipped to dealers prior to development testing completion. Suspect PABs without developmental testing completed may not perform as expected when commanded to deploy in a vehicle crash. A PAB that does not perform as expected may increase the risk of injury to a front seat passenger when commanded to deploy in a vehicle crash.

12. Reach through the instrument panel glove box opening to access and disconnect the two instrument panel electrical connectors from the two Passenger Airbag (PAB) initiators (Figure 6).
13. Reach through the instrument panel glove box opening to access and remove and save the two screws that secure the PAB lower bracket to the instrument panel structural support (Figure 6).
14. Remove and save the four screws that secure the two upper PAB mounting brackets to the U-nuts on each side of the PAB retainer or chute on the underside of the instrument panel cover (Figure 6).
15. Remove the PAB module from the instrument panel cover.

16. Carefully position the **NEW** PAB module into the PAB retainer receptacle.
17. Install and tighten the four screws that secure the PAB upper mounting brackets to the U-nuts on the retainer. Tighten the screws to 27 in. lbs. (3 N·m).

18. Reach through the instrument panel glove box opening to install and tighten the two screws that secure the PAB lower bracket to the instrument panel structural support. Tighten the screws to 106 in. lbs. (12 N·m).

19. Reach through the instrument panel glove box opening to access and connect the two instrument panel wire harness connectors to the two PAB initiators, one at each side of the PAB inflator canister. Be certain the connectors are each fully engaged and locked.
