December 2019

Dealer Service Instructions for:

Equipment Safety Recall VB9 / NHTSA 19E-077 Electric Power Steering Gear

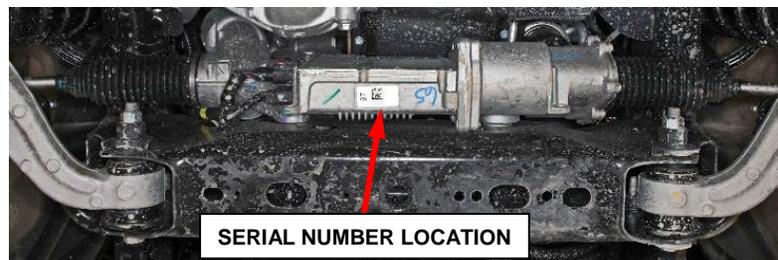
Figure 1 – Serial Number Location

1. If customer brings only the EPS gear for inspection, proceed to **Step 4**.
2. Position the vehicle on a suitable lift then raise and support the vehicle.
3. **If Equipped**, remove the front skid plate.
4. Locate and read the serial number on the EPS gear (Figures 1 and 2).
5. Compare EPS gear serial number to recalled EPS gear serial number list:
