**PRODUCT CAMPAIGN BULLETIN**

<p><b>APPLICABILITY:</b> 2010-2014 MY Legacy          2010-2014 MY Outback          2010-2013 MY Forester          2010-2014 MY Tribeca          2010-2011 MY Impreza          2010-2014 MY WRX and STI</p> <p><b>SUBJECT:</b> Takata Front Passenger Airbag Module / Inflator Replacement (2019 Calendar year expansion)</p>	<p><b>NUMBERS:</b> TKA-19R          TKB-19R          TKC-19R</p> <p><b>DATE:</b> 01/14/19</p> <p><b>REVISED:</b> 12/28/23</p> <p><b>NHTSA ID:</b> 19V-007          19V-008          19V-009</p>
---	---

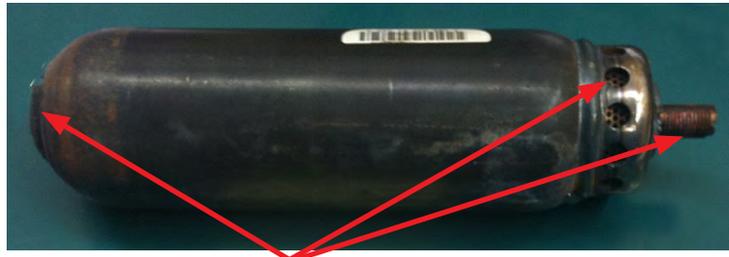
**The shape, holes, and copper-colored stud indicate this not a Genuine Subaru inflator.**

- **Do not proceed with this repair if your inspection reveals a non-Genuine Subaru airbag module has been installed in the vehicle.** Follow the instructions described in the “Counterfeit Airbag Information” Dealer Advisory Bulletin.

- Document the presence of the aftermarket or counterfeit device on the repair order and with photos. Report this information immediately on a Quality Monitoring Report (QMR). **IMPORTANT:** When entering a related QMR, use failure code **ULF** and **NOT** the campaign fail code.
