**PRODUCT CAMPAIGN BULLETIN**

<p><b>APPLICABILITY:</b> 2010-2014 MY Legacy          2010-2014 MY Outback          2010-2013 MY Forester          2010-2014 MY Tribeca          2010-2011 MY Impreza          2010-2014 MY WRX and STI</p> <p><b>SUBJECT:</b> Takata Front Passenger Airbag Module / Inflator Replacement (2019 Calendar year expansion)</p>	<p><b>NUMBERS:</b> TKA-19R          TKB-19R          TKC-19R</p> <p><b>DATE:</b> 01/14/19</p> <p><b>REVISED:</b> 12/28/22</p> <p><b>NHTSA ID:</b> 19V-007          19V-008          19V-009</p>
---	---

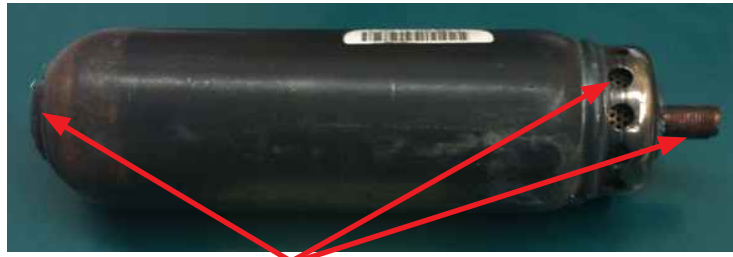
The shape, holes, and copper-colored stud indicate this not a Genuine Subaru inflator.

- **Do not proceed with this repair if your inspection reveals a non-Genuine Subaru airbag module has been installed in the vehicle.** Follow the instructions described in the “Counterfeit Airbag Information” Dealer Advisory Bulletin.
