Campaign No. 2020080007, August 2020

SUBJECT: Model W204 Model Years 2012-2014 Replace Front Passenger-side Airbag

Recall Campaign Bulletin

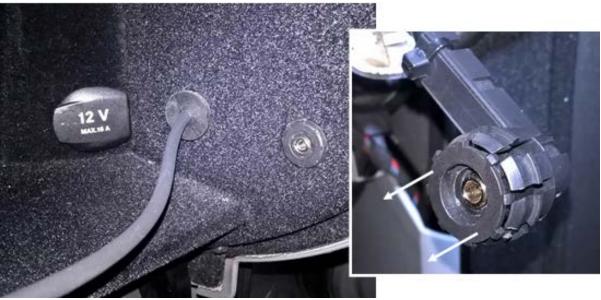
Figure 3

i Release inner retaining ring **(figure 3)** at the AUX connection towards the inside. The connection can then be removed from the glove box housing.

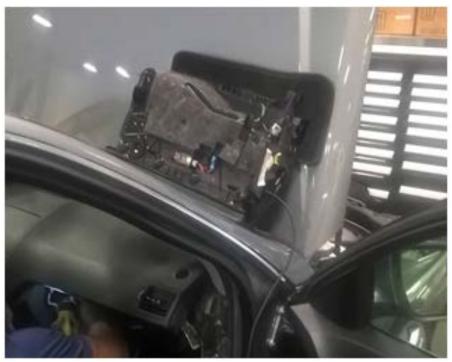
Figure 4

i Pull out the iPod cable as far as possible and set down glove box housing on the windshield *with* exterior iPod cable connected (figure 4).

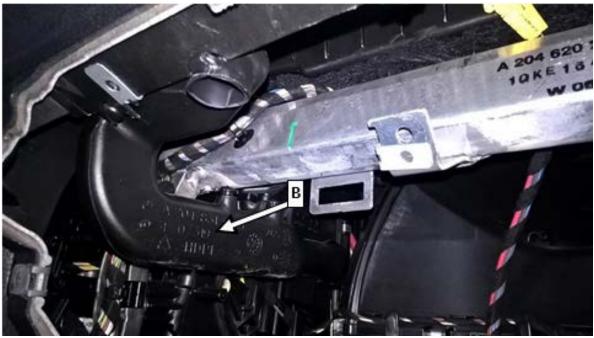
Figure 5

4. Remove air duct (B, figure 5) above the glove compartment.

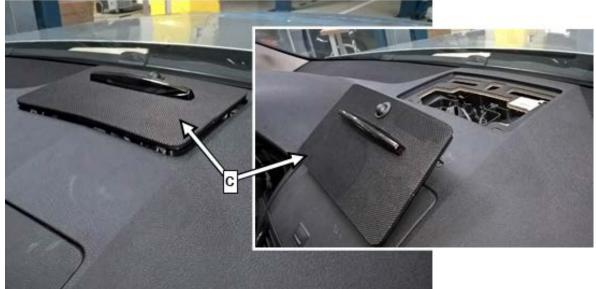
Figure 6

5. Unclip and remove cover (C, figure 6) at the instrument panel on top.i With a sound system, also remove speaker under the cover.

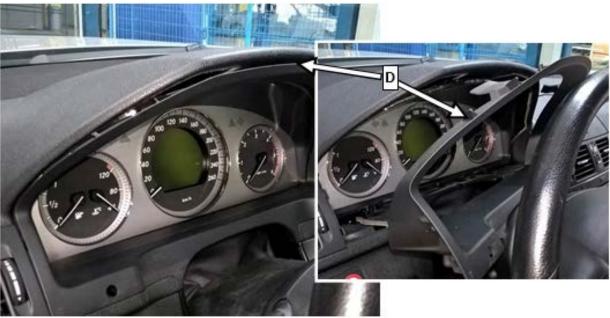
Figure 7

- 6. <u>Remove</u> center console (AR68.20-P-2000CW).
- 7. Remove automatic climate control and operating unit. I For basic data of model W204, see AR83.40-P-6350CW
- 8. Remove trim (D, figure 7) around the instrument cluster.
 I For basic data of model W204, see AR54.30-P-6015CW.

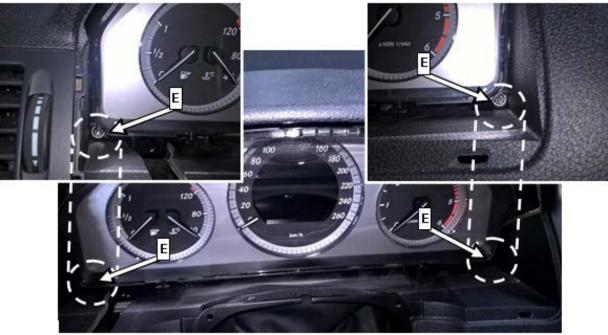
Figure 8

9. <u>Remove the two bottom threaded connections</u> (E, figure 8) of the instrument cluster.

These screws are simultaneously fasteners for the instrument panel.

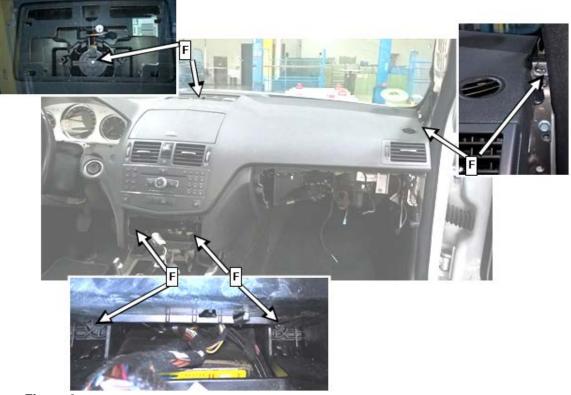
Figure 9

10. Remove four screws (F, figure 9) for fastening the instrument panel

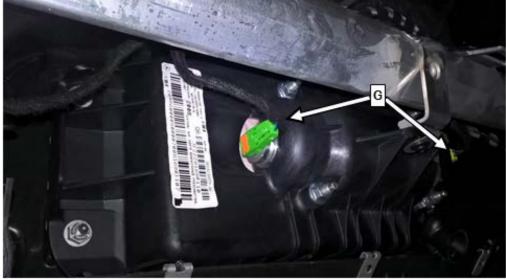
Figure 10

11. Disconnect electrical contacts **(G, figure 10)** at the front passenger airbag.

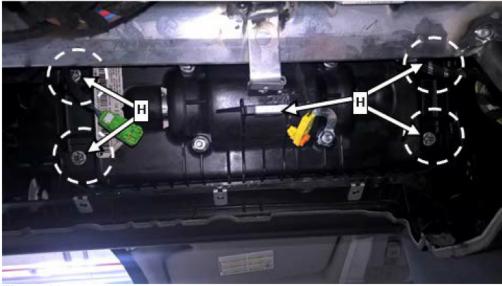
Figure 11

12. Remove lock nuts (H, figure 11) for the front the passenger airbag.

i Lock nuts should only be replaced if they are damaged. For more info see: **AH00.00-N-0001-01A** / **Modification notes 27.10.2016**

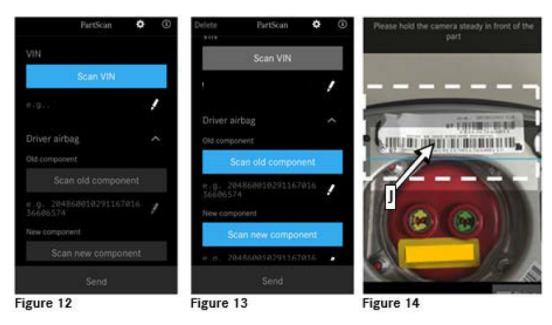
Use the "Scan VIN" button (figure 12) to scan the vehicle identification number either by the barcode or the text field.

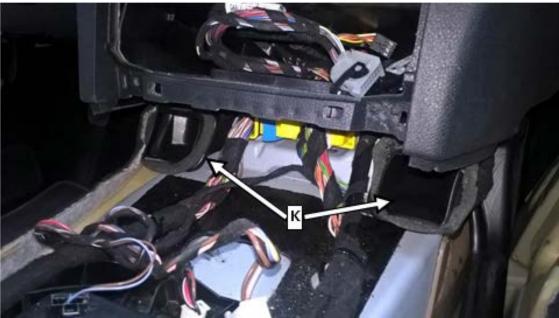
20. Place instrument panel back into position and install the air ducts (K, figure 17) correctly.

i The air ducts are pulled out when the instrument panel is raised.
