Safety Recall

Code: 69S8

Audi

Subject	Driver Frontal Airbag Inflator (Takata)
Release Date	February 18, 2022
Revision Summary	<u>USA ONLY</u> Updated Rental Car/Loaner claiming labor number
Affected Vehicles	U.S.A. & Canada: Certain 2017 MY Audi R8 Spyder and Audi R8 Coupe and Certain 2016-2017 MY Audi TT Roadster and Audi TT Coupe <i>Check Campaigns/Actions screen in Elsa on the day of repair to verify that a VIN qualifies for repair under this action. Elsa is the <u>only</u> valid campaign inquiry & verification source.</i> <ul style="list-style-type: none">✓ Campaign status must show "open."✓ If Elsa shows other open action(s), inform your customer so that the work can also be completed at the same time the vehicle is in the workshop for this campaign.
Problem Description	The driver airbag may explode in a crash with airbag deployment. Sharp metal fragments can hit people and cause serious injury or death.
Corrective Action	Replace the driver frontal airbag.

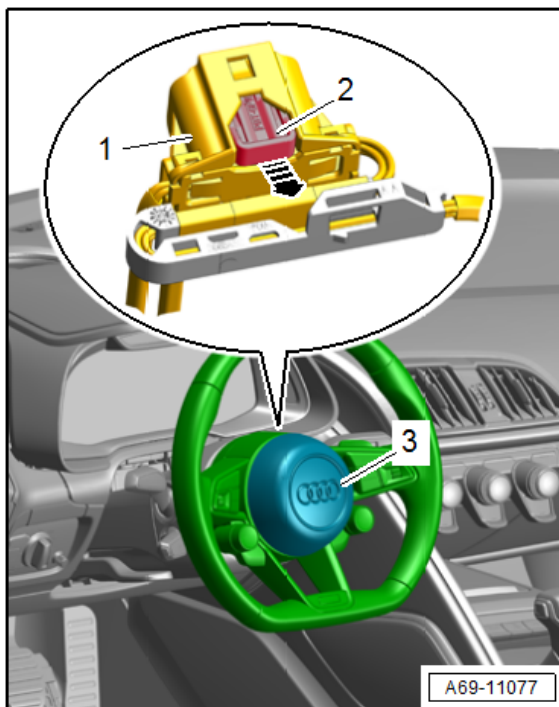
- The driver frontal airbag inflator could potentially rupture (due to propellant degradation occurring after long-term exposure to absolute high humidity and temperature cycling). In the event of an inflator rupture, in very rare cases metal fragments could pass through the airbag cushion material, which may result in serious injury or death.
- All Takata recalls should be performed before any other work is performed on the vehicle.

- Replace driver frontal airbag <3>.
