RECALL 19V-015: DRIVER'S FRONT AIR BAG MODULE – PRIOR PARTS REPLACEMENT

This Service Information bulletin replaces SI B65 05 19 **dated January 2019**

SI B65 05 19 - Recall Campaign : Driver's Air Bag Module

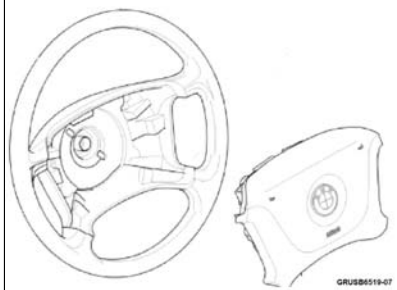
<p>GRUSB519-07</p>	<p>UPDATE! Basic Steering Wheel Equipped Vehicles (with or without MFL button controls) This steering wheel's air bag is NOT affected, air bag removal for inspection is NOT necessary Submit a claim for checking only.</p>

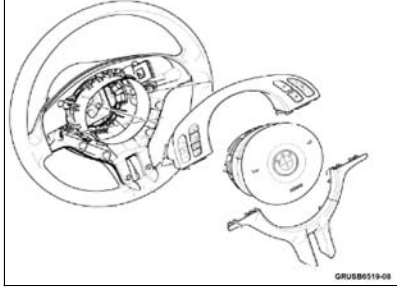
<p>GRUSB519-08</p>	<p>UPDATE! Optional Sports Steering Wheel Equipped Vehicles (with or without MFL button controls) This steering wheel's air bag MAYBE affected, remove, inspect and replace the air bag as necessary. Submit a claim for the inspection or the inspection/replacement repair that applies.</p>

1. Remove the driver's air bag in accordance with repair instructions **REP 32 34 020** "Removing and installing/replacing air bag units".
2. Check the label on the back of the driver's air bag.

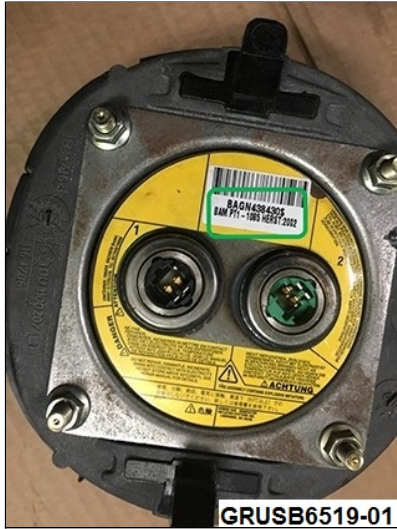
Is the label yellow with a white number sticker with printed serial number BAM XXX - 1085 (as shown below) printed below the bar code?

YES- replace air bag following attached procedure.

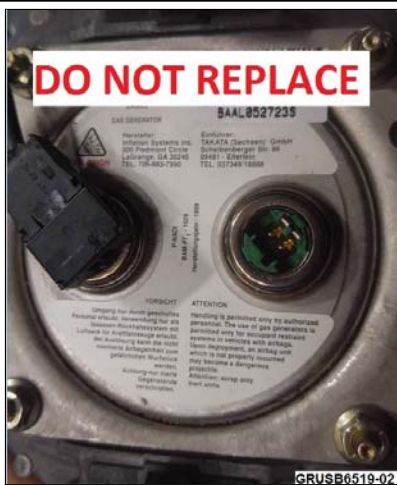
UPDATE! Air bags from other manufacturers (non-Takata, Autoliv), or Takata air bags with different chemical compositions (white label) are not affected by this recall and **DO NOT** need to be replaced. **Reinstall the driver's air bag.**
