SIB 65 05 19

RECALL 19V-015: DRIVER'S FRONT AIR BAG MODULE – PRIOR PARTS REPLACEMENT

This Service Information bulletin (Revision 7) replaces SI B65 05 19 dated **December 2022**.

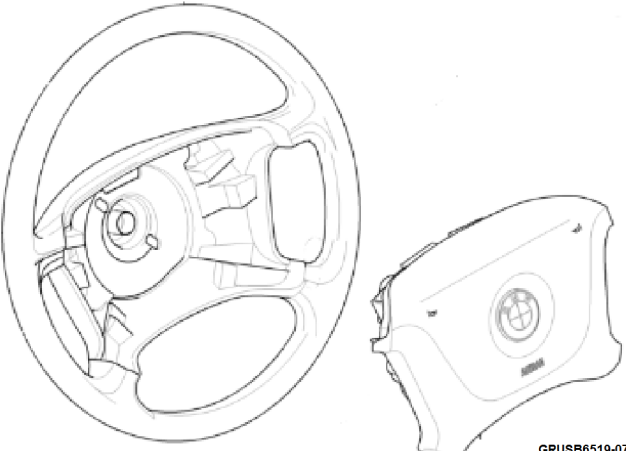
<p>Basic Steering Wheel Equipped Vehicles (with or without MFL button controls)</p> <p>This steering wheel's air bag is NOT affected, air bag removal for inspection is NOT necessary</p> <p>Submit a claim for checking only.</p>

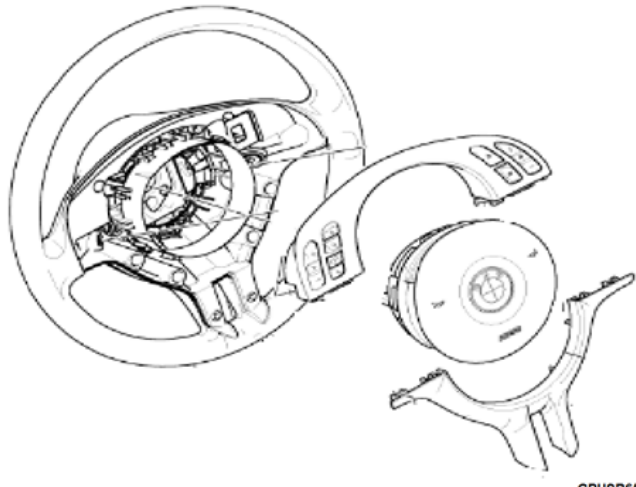
<p>Optional Sports Steering Wheel Equipped Vehicles (with or without MFL button controls)</p> <p>This steering wheel's air bag MAYBE affected, remove, inspect and replace the air bag as necessary.</p> <p>Submit a claim for the inspection or the inspection/replacement repair that applies.</p>
	<p>Vehicles equipped with Optional Sports Steering Wheel only</p> <ol style="list-style-type: none"> 1. Remove the driver's air bag in accordance with

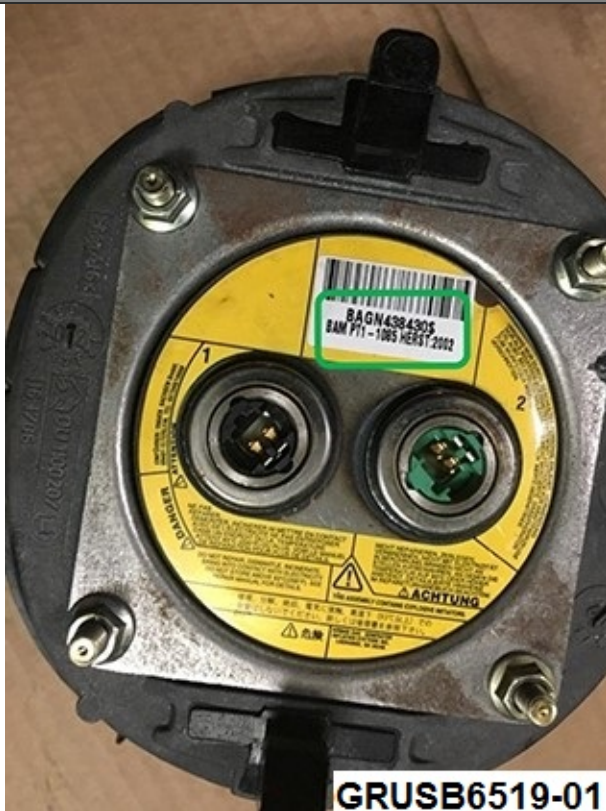
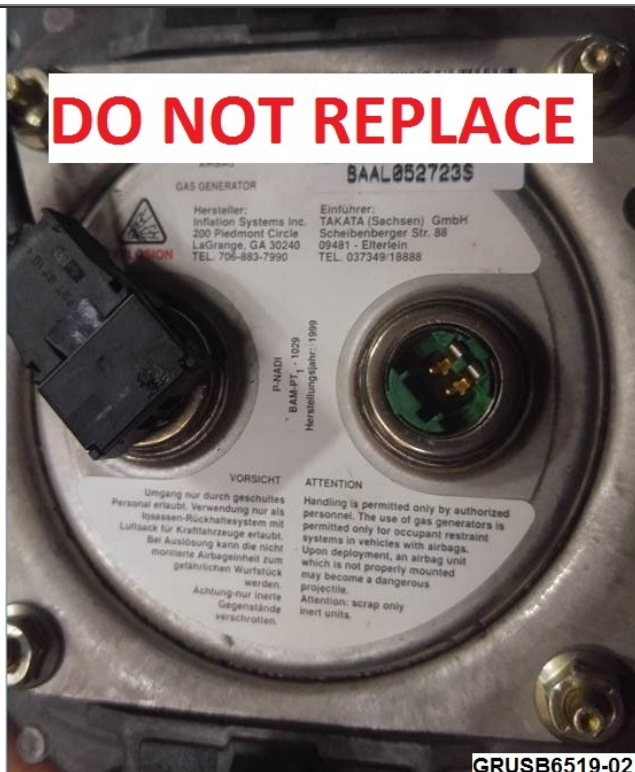
2. Check the label on the back of the driver's air bag.

Is the label yellow with a white number sticker with printed serial number BAM XXX - 1085 (as shown) printed below the bar code?

YES- replace air bag following attached procedure.

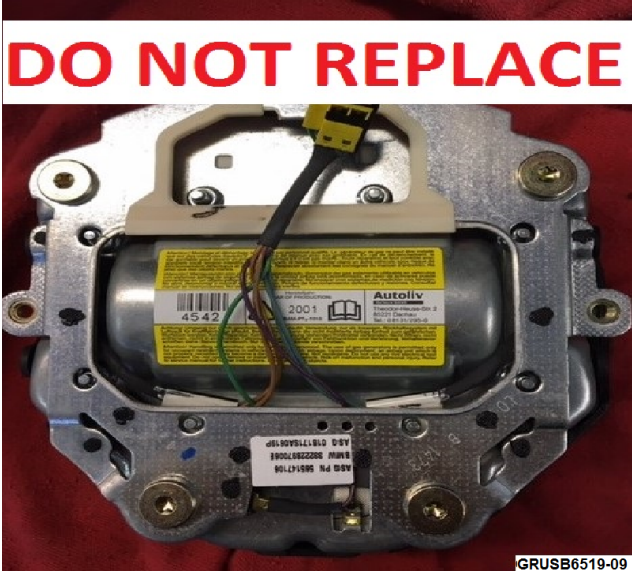
Air bags from other manufacturers (non-Takata, Autoliv), or Takata air bags with different chemical compositions (white label) are not affected by this recall and DO NOT need to be replaced.

<p>DO NOT REPLACE</p> <p>GRUSB6519-09</p>
