SIB 65 05 19

RECALL 19V-015: DRIVER'S FRONT AIR BAG MODULE – PRIOR PARTS REPLACEMENT

This Service Information bulletin (Revision 5) replaces SI B65 05 19 dated October 2019

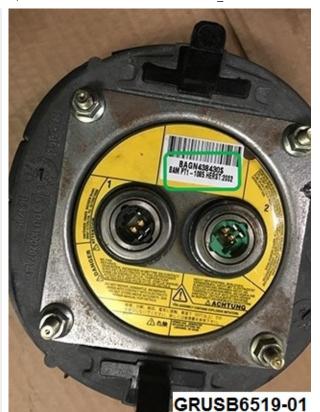
Is the label yellow with a white number sticker with printed serial number BAM XXX - 1085 (as shown) printed below the bar code?

YES- replace air bag following attached procedure.

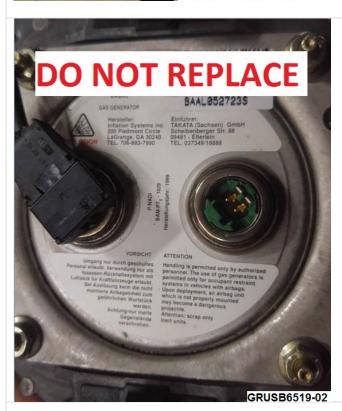
NO - the driver's air bag is not affected.

Air bags from other manufacturers (non-Takata, Autoliv), or Takata air bags with different chemical compositions (white label) are not affected by this recall and **DO NOT** need to be replaced.

Reinstall the driver's air bag.
