SIB 65 02 19

RECALL 19V-017: PASSENGER'S FRONT AIR BAG MODULE

E70 (X5 incl. Diesel)	E71 (X6, incl. M)	E72 (X6 ActiveHybrid)
-----------------------	-------------------	-----------------------

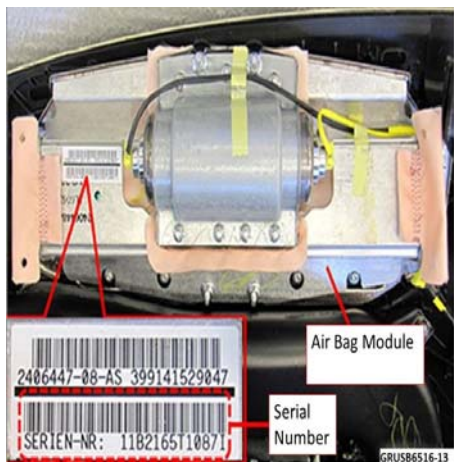
It is necessary to document which air bag goes into which vehicle. Therefore the technician is required to note on the repair order the serial number of the new air bag. The serial number should also be entered into the warranty claims comment section.
