MODEL: E/J	TYPE: Field Change Program	SECTION/GROUP: 02 – Rear Axle Steering	DATE: January 16, 2019
--------------------------	--	--	--

Ref. MCI NHTSA Recall No.: 19V-XXX

Ref. MCI Transport Canada Recall No.: 2019-006

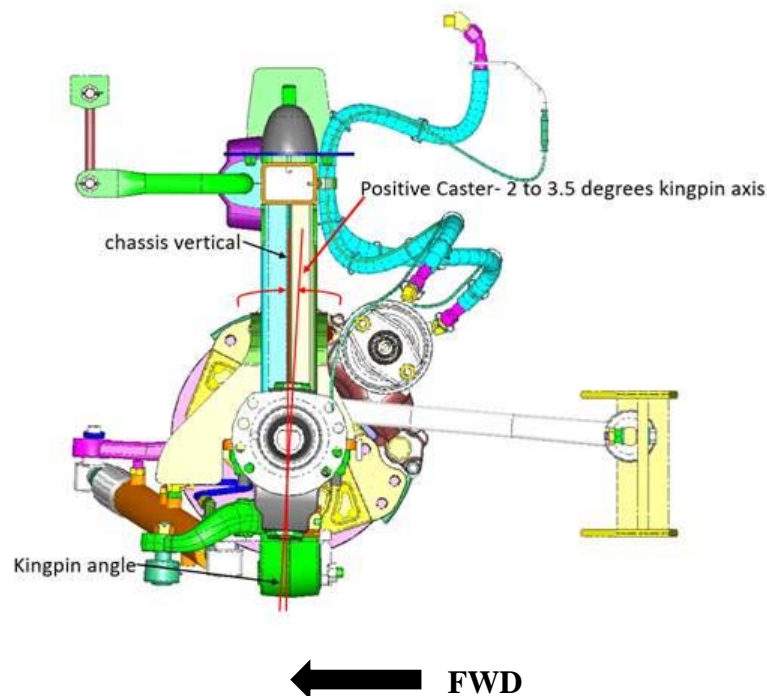
Tag axle caster should be nominally set at a positive 3 degrees. Acceptable range is positive 2 to 3.5 degrees as shown in the picture below.

3.1 Measure the caster using a Hunter Engineering bus alignment machine or equivalent. Reference MCI Maintenance Manual Section 2C.
