Subject: Steerable Tag-Axle Evaluation			
Field Change Program: Field Campaign	FCP Number: 469	Revision: B	Date: 04/01/2021
Coach Section: 11-Steering	P/N: N/A		Type: Safety Recall

Ref. NHTSA Recall No.: 19V-027	Ref. Transport Canada Recall No.: 2019-006
--	--

The vehicles that exhibit this problem are the 1997 – 2013 MCI 102EL3 / 4500 and 2001 - 2015 MCI J4500 model coaches that have the active hydraulic rear axle steering system.

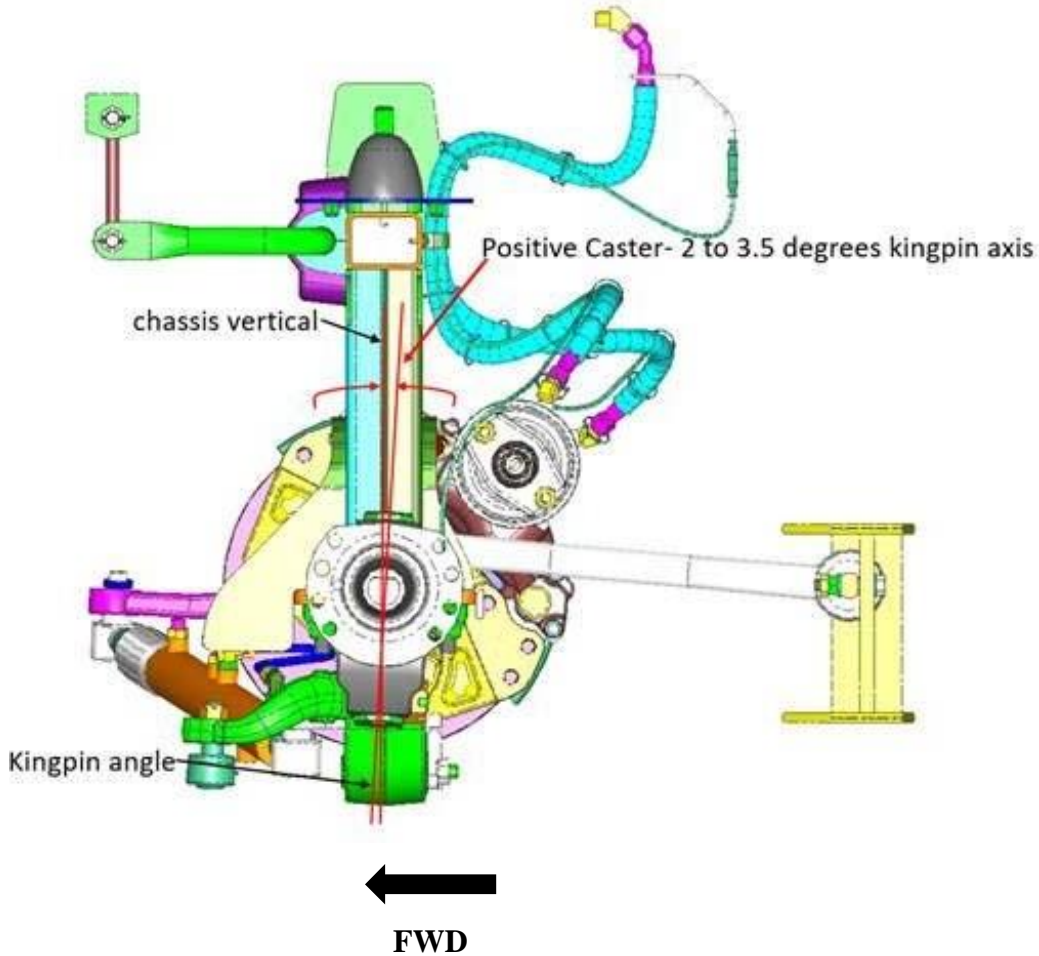
Tag axle caster should be nominally set at a positive 3 degrees. Acceptable range is positive 2 to 3.5 degrees as shown in the picture below.

5.1 Measure the caster using a hunter engineering bus alignment machine or equivalent. Reference MCI maintenance manual section 2C.

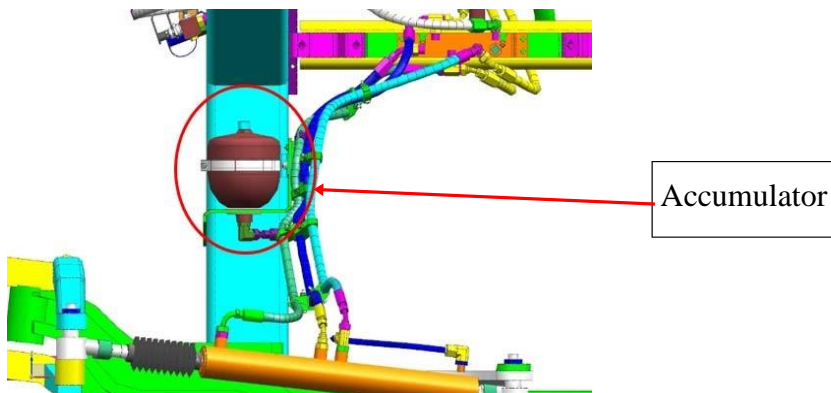
- a. To check the RAS system accumulator (located just behind the curbside tag tire), the RAS system pressure must first be lowered to approximately zero by connecting to L1, L2 and L3 ports (located in the curbside rear engine access panel) and draining the fluid.

- b. Then remove the cap on top of the accumulator and loosen slightly the hexagon socket head plug that is under the cap previously removed. Connect the accumulator pressure measurement, tool part number T20-1255, using adapter fitting T19-1155, to the top of the accumulator. Using the tool connection to the accumulator, slightly loosen the hexagon socket head screw until the accumulator pressure is being read by the gauge on the pressure measurement tool.

- c. If the pressure reading is less than 20 psi, replace the accumulator. If the pressure in the accumulator is above 20 psi, charge the accumulator using the tool previously attached to accumulator with dry nitrogen to 145 to 160 psi.

- d. Allow 5 minutes for the gas temperature to equalize, recheck the accumulator pressure, and adjust the pressure if necessary. Again wait 5 minutes and check the accumulator pressure. If the accumulator pressure is dropping, replace the accumulator since it has an internal leak. If the accumulator pressure is holding pressure, tighten the hexagon socket plug using the accumulator tool and then remove the accumulator tool. Torque the hexagon socket plug to 18 ft-lbs (25 nm). Reinstall the cap at the top of the accumulator.
