Field campaign

Topic	Mulsanne - Rear seat belt anchor plate installation (RE19/01)
Market area	Bentley: worldwide (2WBE),Hongkong-Macau (5HK)
Brand	Bentley
Transaction No.	2052868/1
Campaign number	RB15
Note	
Type	
US code

Mulsanne - Five seat variant

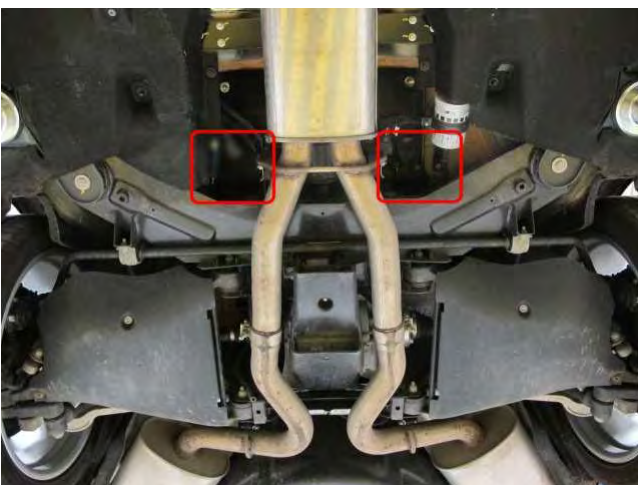
Figure 2

Referring to Figure 2, conduct a visual inspection of the rear floor panel using the left and right hand access points shown, the operative should look directly above the front section of the rear subframe, the rework status can be easily identified by the colour of the underseal which is applied

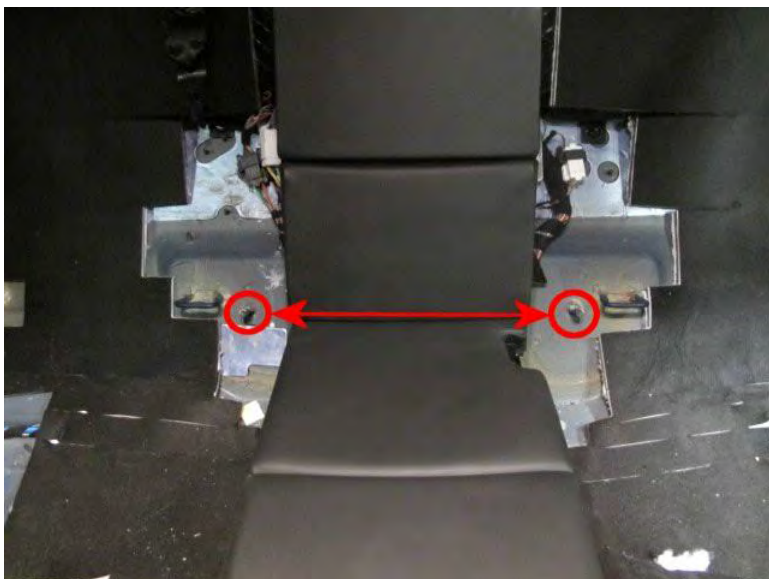
The right and left hand inner rear seat frame studs as shown in Figure 1 are located on opposing sides of the propshaft tunnel, the studs are used to locate and secure the rear seat frames, centre seat belt buckle and the seat belt anchor to the rear floor panel

Both studs require removal, once removed the installation of pre-assembled plates is required to the left and right hand side

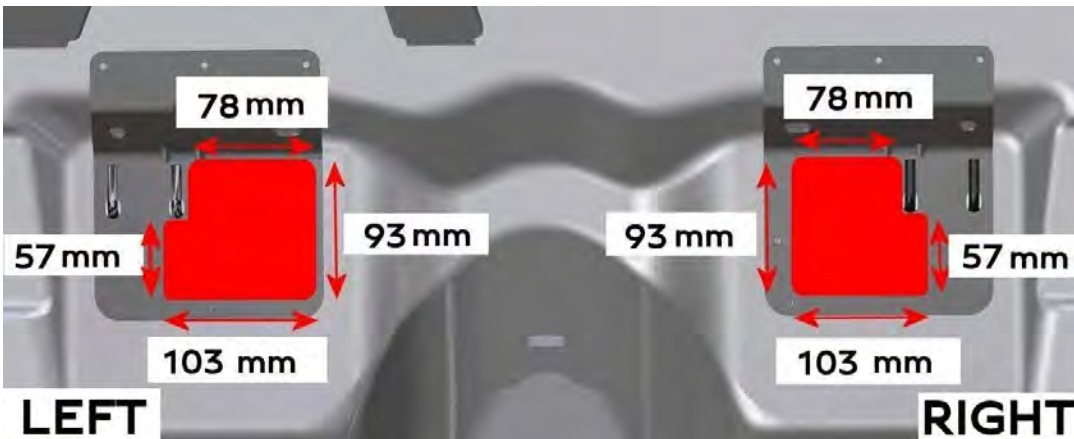
It is imperative that the areas shown in Figure 20 are completely free of underseal as per the dimensions provided, should the operative **NOT** remove **ALL** underseal the fitting location of the plates in relation to the floor panel may be compromised

6) Referring to Figure 20 - Scrape/remove the underseal from the areas shown on the right and left hand side, once removed use fine grade sandpaper to remove any remaining underseal

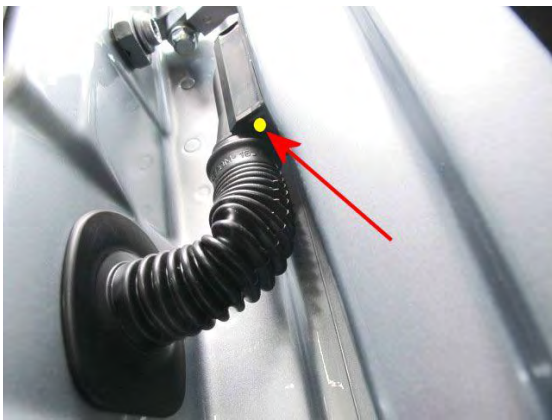
Figure 36

Yellow paint mark on the underside of the left hand rear door harness connector (Figure 36)

16) Apply a Yellow paint mark on the underside of the left hand rear door harness connector (Figure 36)
