# Keystone RV Company

3/7/2019

## SAFETY ADVISORY # 19-341

### Montana 3854BR/3855BR Slide Rams

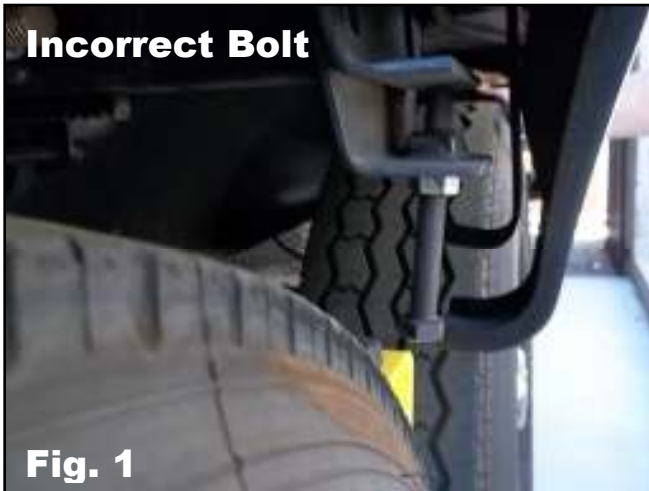
If there is less than 2 ¾" of space between the bolt head and tire replace the bolt with the part number provided above. See Figure 1 for incorrect bolt and Figure 2 for correct bolt. Using a ratchet and ¾" socket, remove the existing bolt. Start the new bolt by hand and finish with the ratchet, install the bolt firmly against the adjustment plate.
