GROUP	NUMBER
CAMPAIGN	19-01-012H
DATE	MODEL(S)
JULY 2019	TUCSON (LM)

TUCSON 2.4L ENGINE INSPECTION /

SUBJECT: OIL PRESSURE SWITCH AND OIL PAN INSTALLATION

(RECALL CAMPAIGN 181)

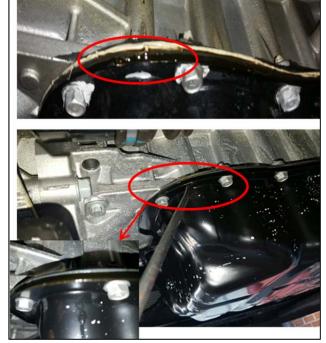
1. Lift the vehicle and remove the undercover (A).

2. Inspect for engine oil leakage from the engine oil pan.

<u>If there is evidence of oil leakage (past or present):</u>

Replace the oil pressure switch and oil pan according to the following service procedure.

If there is NO evidence of oil leakage:

Replace the oil pressure switch according to the following service procedure.
