**PRODUCT CAMPAIGN BULLETIN**

**APPLICABILITY:** 2019MY Forester and Crosstrek Vehicles      **NUMBER:** WUC-88  
**SUBJECT:** Power Steering Gear Box Inspect/Replacement      **DATE:** 02/12/19  
**NHTSA ID:** 19V-065

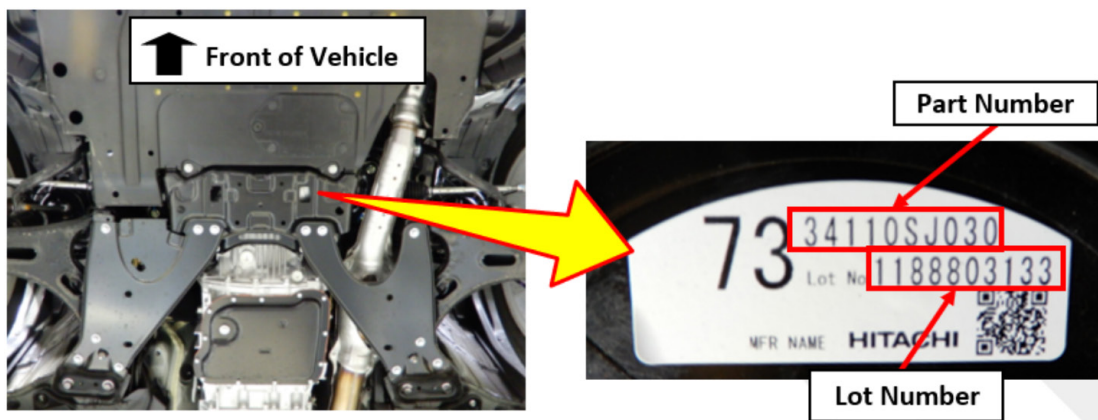
- 1) After confirming applicability, raise the vehicle on a lift.
- 2) The EPS Label and Lot Number are accessible through a hole in the crossmember support as shown.

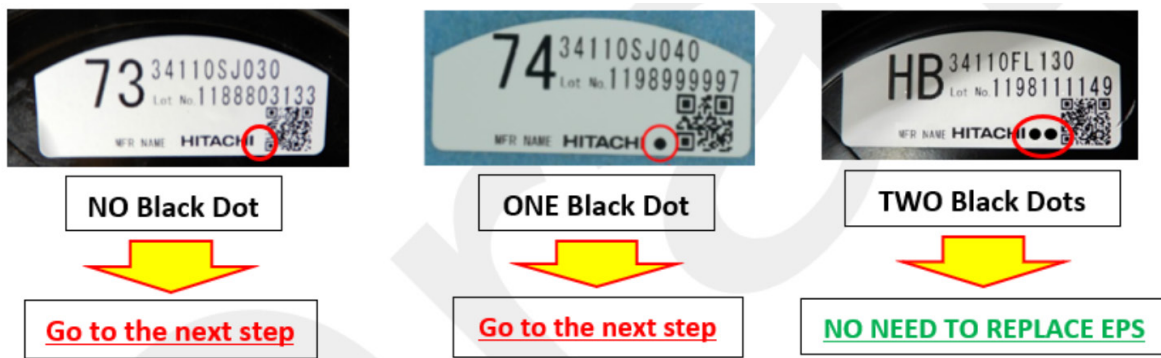
3) Inspect the label for black dots to the left of the QR code as shown.

If inspection reveals a label with TWO (2) dots, the Service Procedure is complete. **CAREFULLY** copy the Lot Number onto the Repair Order as it will be needed for Claim Submission. Proceed to Claim Reimbursement and Entry Procedures to process the claim for Inspection Only.

If inspection reveals a label with either NO or only ONE dot, **CAREFULLY** copy the Lot Number onto the Repair Order then compare it to the ranges provided below. **NOTE:** Parts within these lot number ranges may be found on either Crosstrek or Forester as both of the vendor's production lines produce parts for both carlines.

If the Lot Number falls within either of these ranges, the EPS assembly **MUST** be replaced.
