PRODUCT CAMPAIGN BULLETIN

APPLICABILITY: 2019MY Forester and Crosstrek Vehicles **NUMBER:** **WUC-88R**
SUBJECT: Power Steering Gear Box Inspect/Replacement **DATE:** 02/12/19
REVISED: 03/21/19
NHTSA ID: 19V-065

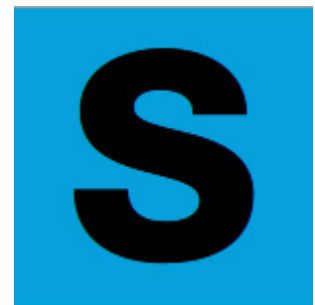
These vehicles can be quickly identified upon receipt by the presence of an "S" label with blue background on the windshield as shown here. While all affected vehicles should have this label installed at the ports, retailers should always check arriving potentially applicable vehicles using vehicle inquiry to confirm if there are any open recalls/campaigns to be completed. In a small number of cases, an "S" written with a glass marker may be found on the windshield in place of the sticker.

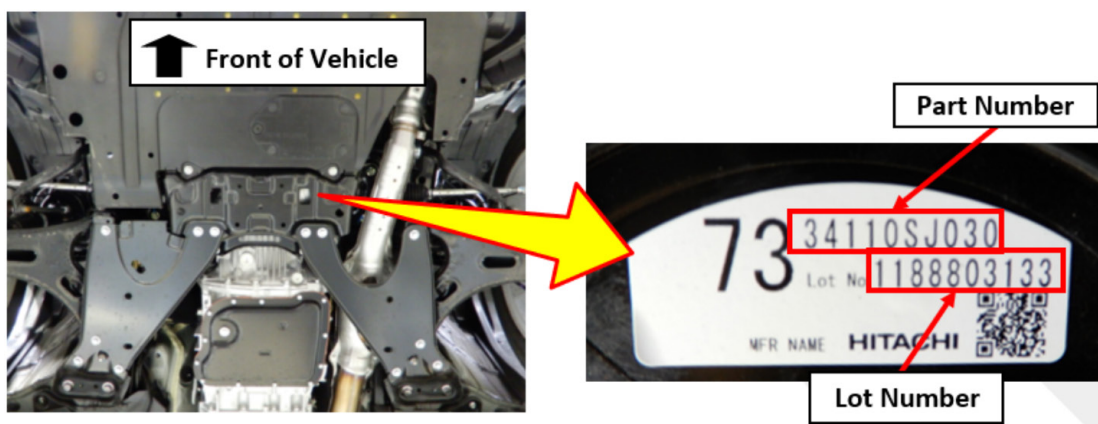
- 1) After confirming applicability, raise the vehicle on a lift.
- 2) The EPS Label and Lot Number are accessible through a hole in the crossmember support as shown.

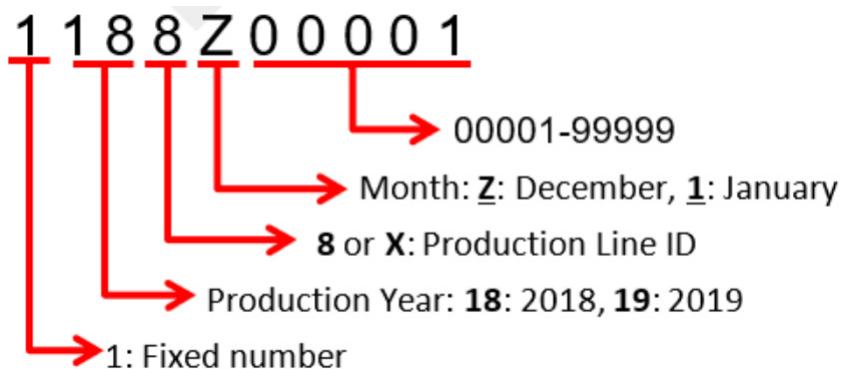
1188Z21674 – 1198199999

118XZ10278 - 119X199999

Use the image below for interpreting the Lot Number of the EPS gear box assembly.

If the Lot Number falls within either of these ranges, the EPS assembly **MUST** be replaced.

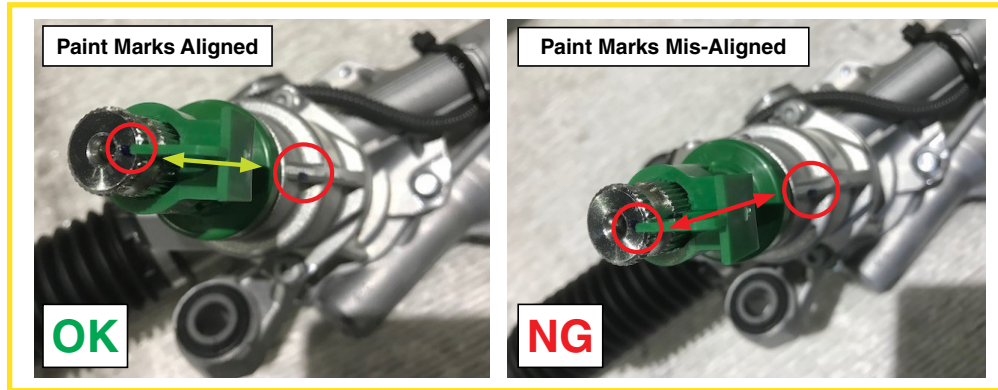
There is a VERY SMALL possibility the EPS gear box assembly was not properly centered before the plastic retainer was installed during manufacturing. If this occurs:

- it may be difficult to match up the marks when re-connecting the EPS gear box assembly to the steering shaft
- the number of turns between full steering lock left and right will be different
- one tie-rod boot will be collapsed (or extended) more than the other.

- If a **NG** condition is identified, see **APPENDIX A** on page 9 of this bulletin for the **EPS Gear Box Centering Procedure**.
 - Although the plastic retainer cap is white in the photos, it will likely be either green or blue depending on application.
5. When the Lot Number inspection procedure determines the EPS gear box assembly requires replacement, follow the procedure in the applicable Service Manual along with the Helpful Hints provided below. Pay close attention to the items listed as one-time-use. They are all supplied in the Hardware Kit and **MUST** be replaced during reassembly.
