May 2019  
INT FL806-01/02  
NHTSA #19V-066  
Transport Canada #19-054  
**INTERIM RECALL BULLETIN**  
THIRD REVISED NOTICE

## **Subject: Freightliner Cascadia Steering Wheel Airbags**

**Models Affected: Specific Freightliner Cascadia vehicles manufactured August 3, 2017, through January 30, 2019.**

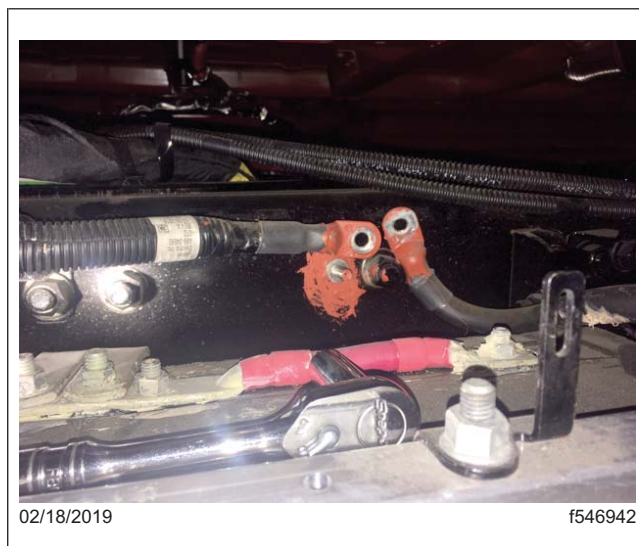
**Fig. 1, GNDE Frame Rail Stud**

6. Open the hood.
7. Inspect the vehicle frame rail GNDE and GNDP studs. See [Fig. 1](#) and [Fig. 2](#). Use lacquer thinner, as needed, to clean off any excess paint on electrical connections throughout these instructions.

8. Verify that the Electrical Ground (GNDE) and the Power Ground (GNDP) frame rail studs are clean and torqued correctly. Disassemble and inspect the studs for overspray on the flat surfaces, and in between the ring eyes. Torque these frame rail ground studs 14 lbf·ft (19 N·m). Repaint the connection as necessary.

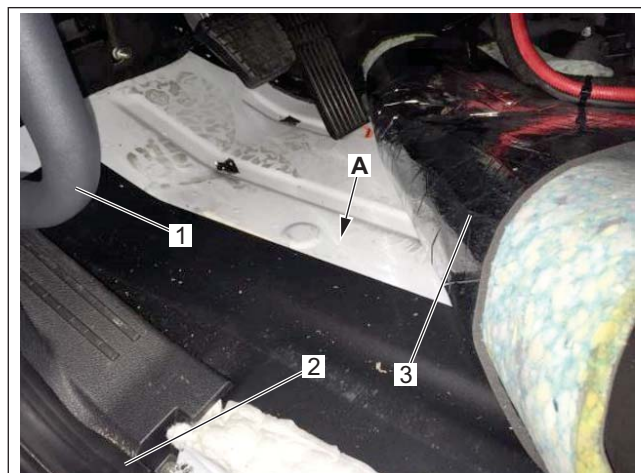
**Fig. 3, GNDE Floor Stud Location**

- A. Location of the GNDE floor stud, approximately 5/16 inch (7.9 mm) from the edge of the rivet.
1. Grab Handle (for reference)
  2. Lower A-Pillar Cover
  3. Floor Mat

- 10.1 Remove the driver's-side sill cover, the lower A-pillar cover, and the lower steering wheel cover. See [Fig. 3](#).
- 10.2 Roll back the driver's-side floor mat far enough to access the center floor area above the stud, where the bolt is installed.
- 10.3 Locate the mounded area on the floor, directly above the GNDP stud location.
- 10.4 Locate and mark a spot directly between the mound and the closest rivet. The center will be approximately 5/16 inch (7.9 mm) from the edge of the rivet. Verify the area below the floor is clear, and drill a 5/16 inch (7.9 mm) hole through the aluminum floor at the spot marked. See [Fig. 4](#).
