May 2019  
INT FL806-01/02  
NHTSA #19V-066  
Transport Canada #19-054  
**INTERIM RECALL BULLETIN**  
SECOND REVISED NOTICE

## **Subject: Freightliner Cascadia Steering Wheel Airbags**

**Models Affected: Specific Freightliner Cascadia vehicles manufactured August 3, 2017, through January 30, 2019.**

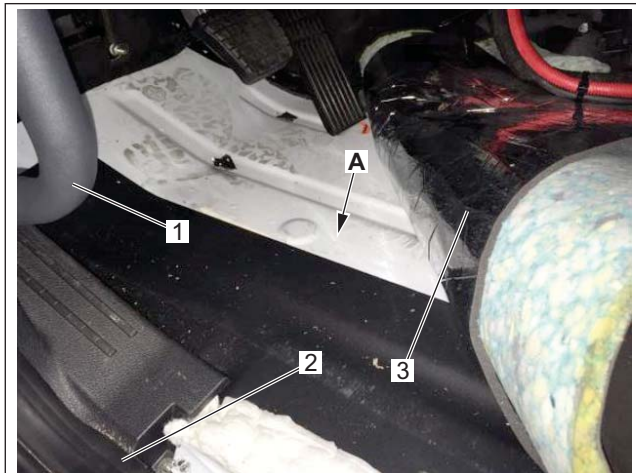
**Fig. 3, GNDE Floor Stud Location**

- A. Location of the GNDE floor stud, approximately 5/16 inch (7.9 mm) from the edge of the rivet.
1. Grab Handle (for reference)
  2. Lower A-Pillar Cover
  3. Floor Mat

- 10.1 Remove the driver's-side sill cover, the lower A-pillar cover, and the lower steering wheel cover. See [Fig. 3](#).
- 10.2 Roll back the driver's-side floor mat far enough to access the center floor area above the stud, where the bolt is installed.
- 10.3 Locate the mounded area on the floor, directly above the GNDP stud location.
- 10.4 Locate and mark a spot directly between the mound and the closest rivet. The center will be approximately 5/16 inch (7.9 mm) from the edge of the rivet. Verify the area below the floor is clear, and drill a 5/16 inch (7.9 mm) hole through the aluminum floor at the spot marked. See [Fig. 4](#).
