SIB 63 02 19

## RECALL CAMPAIGN 19V-074: REAR TAIL LIGHT

F48 (X1 SAV)

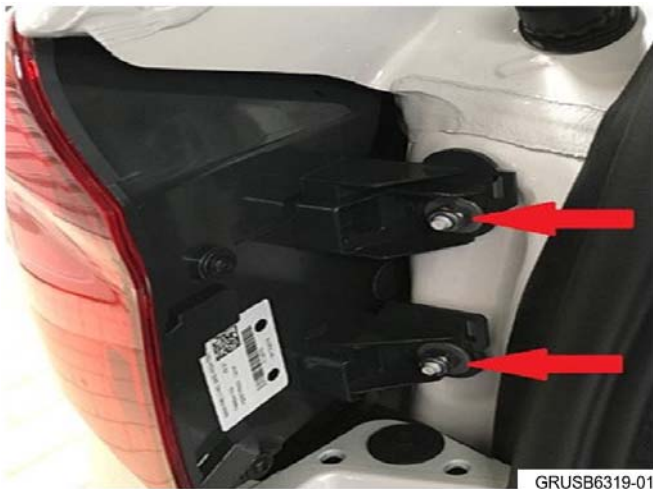
GRUSB6319-01

1. Remove the water channel trim on both tail lights, following repair instructions REP 63 21 400 "Replace trim for water channel (left or right).

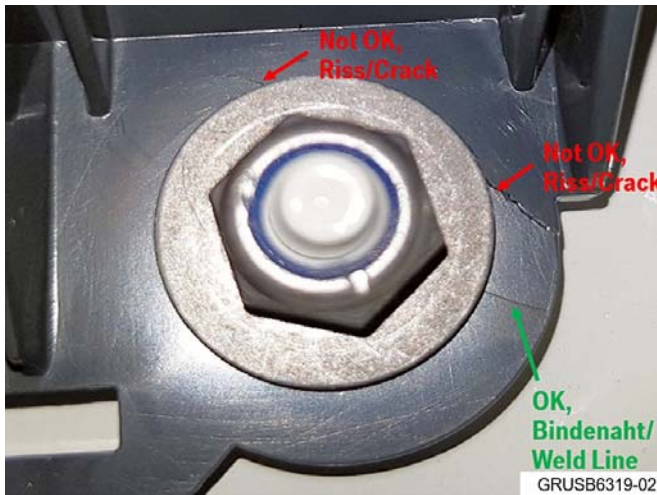
GRUSB6319-02

2. Before removing the tail light mounting nuts, carefully inspect the tail light mounting areas shown to the left for signs of cracking.

Ensure the tail lights are only replaced in case of cracking.

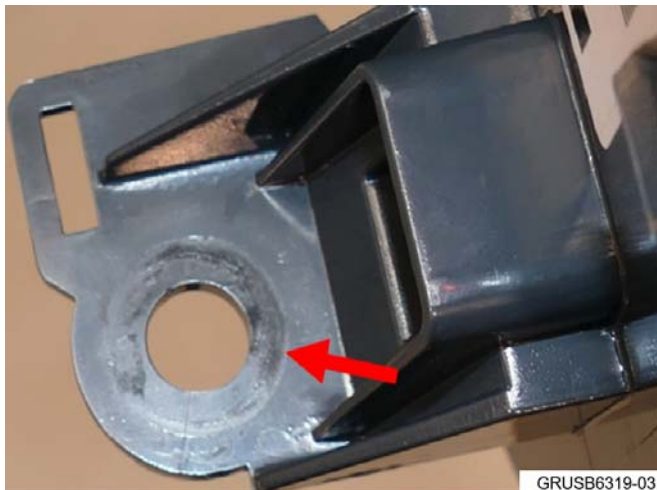
GRUSB6319-03

4. Immediately secure the tail light mounting nuts so that they cannot be reused.

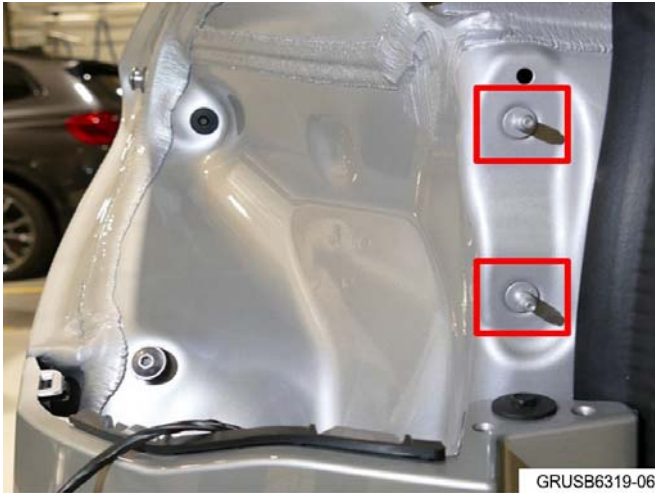
5. With the tail lights removed, re-inspect both sides of the tail light mounting tabs for signs of cracking.

Inspect the mounting tabs of the tail lights for signs of oil residue. Examples of oil residue on the mounting tabs can be seen to the left. All 3 photos to the left show indications of oil residue and are NOT OK.

**6. With the rear lights removed from the vehicle, the tail light mounting studs and vehicle body MUST be cleaned to remove potential residual manufacturing oil.**

Using an 80% ethanol/20% water mixture on a clean cloth, clean the mounting studs and body area shown to the left.
