SI B63 02 19
Lights

RECALL CAMPAIGN 19V-074: REAR TAIL LIGHT

F48 (X1 SAV)

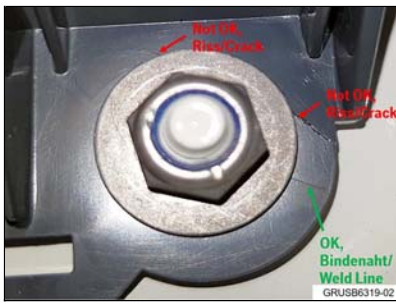
2. **Before** removing the tail light mounting nuts, carefully inspect the tail light mounting areas shown to the left for signs of cracking.

Note: Casting lines in the plastic as shown to the left are not a defect.

Ensure the tail lights are only replaced in case of cracking.

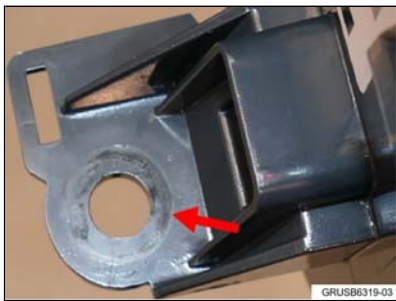
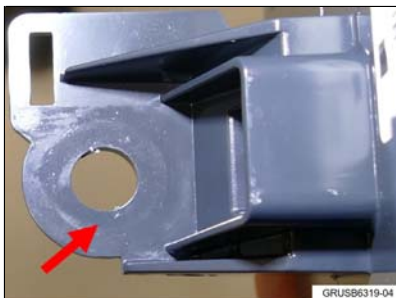
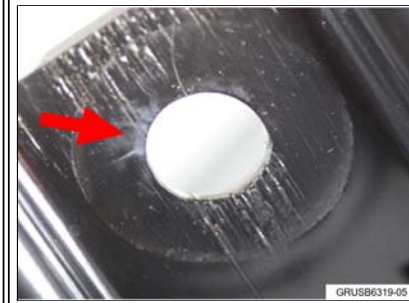
During assembly, oil may have contaminated the plastic housing of the rear tail lights, causing damage to the mounting points of the tail light assembly.

5. With the tail lights removed, re-inspect both sides of the tail light mounting tabs for signs of cracking. Inspect the mounting tabs of the tail lights for signs of oil residue. Examples of oil residue on the mounting tabs can be seen to the left. All 3 photos to the left show indications of oil residue and are **NOT OK**.

YES: Replace both tail lights and continue to step 8.

8. Replace all tail light mounting nuts. Torque the replacement nuts to 2.8nm.
