Subject: Hendrickson 5 Inch Drop Axle Tie Rods

Models Affected: Specific Freightliner Cascadia vehicles manufactured April 30, 2012, through May 26, 2015, equipped with Hendrickson 5 inch drop axle tie rods, brake linings, and stamped spiders.

Recall Campaign

April 2019 FL807A-D NHTSA #19V-093 Transport Canada #2019-066

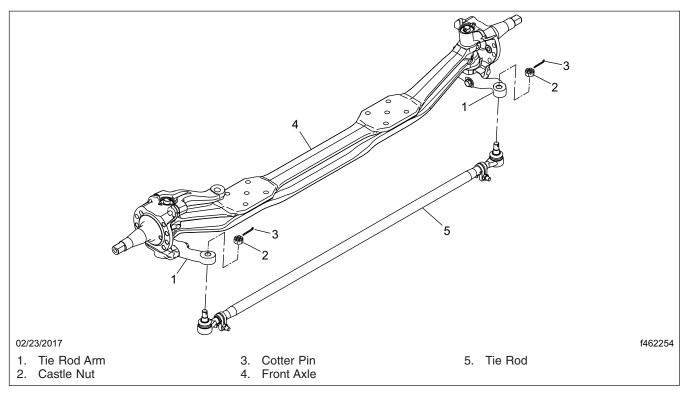
Fig. 1, Tie Rod Assembly

In certain circumstances, high brake vibrations may occur due to a specific combination of Hendrickson 5 inch drop axle tie rods, brake linings, and stamped spiders. These vibrations may lead to a reduced fatigue life and early separation of the tie rod. Separation of the tie rod may lead to a disconnect between the front wheels of the vehicle and reduce the ability to steer the vehicle, which could increase the risk of a crash.

- Remove the brake assembly. Refer to the applicable section in Group 42 of the Cascadia Workshop Manual.
- 7. Disconnect the tie rod from the tie rod arms; see Fig. 1. Remove the tie rod from the vehicle and discard it.

- 8. Attach a new tie rod to the tie rod arms. Tighten the castle nut 120 to 170 lbf-ft (163 to 230 N·m) plus a maximum of one-sixth of a turn to align a slot in the castle nut with the cotter pin hole in the tie rod stud. Insert the cotter pin and bend the tangs to secure it.
- 9. Clean and inspect all brake parts that will be reused. Refer to the applicable section in **Group 42** of the *Cascadia Workshop Manual*.
