GROUP  
**Safety Recall Campaign**

MODEL  
**2011-2012MY  
Sportage (SL)**

NUMBER  
**SC174**

**SUBJECT:** SL THETA II 2.4 MPI ENGINE OIL PAN  
INSPECTION AND REPLACEMENT

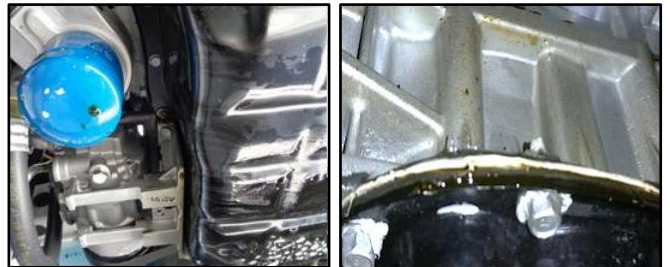
2. Inspect the oil pan area for any oil leak. Sample photos are shown on the right.

Inspection Result	Action
No oil leaking	Replace the OPS <u>only</u> (page 3)
Oil leak visible	Replace <u>both</u> the OPS and Oil Pan. (pages 3 and 4)

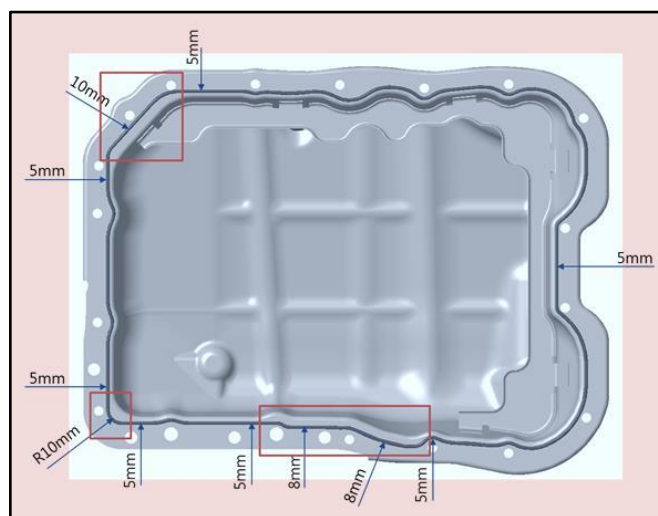
When applying sealant, the sealant must not protrude into the inside of the oil pan. Photo shown on the right provides the recommended distance of the sealant bead placement from the inner edge of the oil pan rim.

- 6a. Apply sealant (UM016 CH123) to the new oil pan. Sealant bead width: 0.08 - 0.12in. (2.5 - 3.0mm)

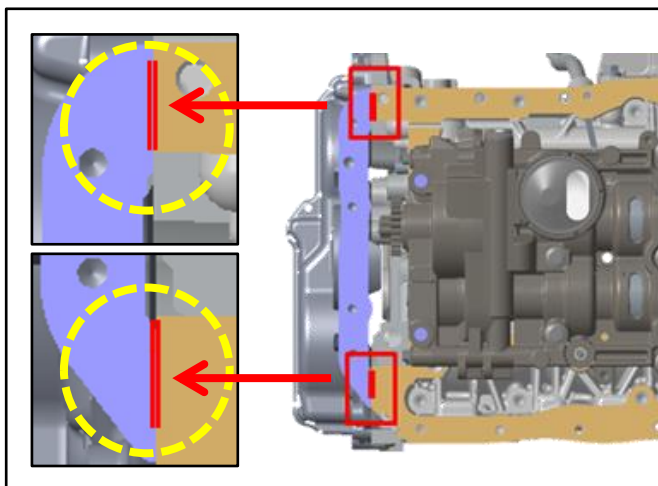
Oil leakage may reoccur if the oil pan is not sealed properly.

- 6b. Apply 2 sealant lines as wide as 0.08in (2.5mm wide) to the area where the engine block and timing cover meet as shown below. **Note:** The oil pan must be installed within five (5) minutes after application of sealant.
