GROUP
Safety Recall Campaign

MODEL
**2015-2018MY
Sedona (YP)**

NUMBER
SC175 (Rev 1, 03/20/2019)

SUBJECT: **FRONT PASSENGER SEAT OCCUPANT DETECTION
SYSTEM (ODS) WIRING HARNESS (SC175)**

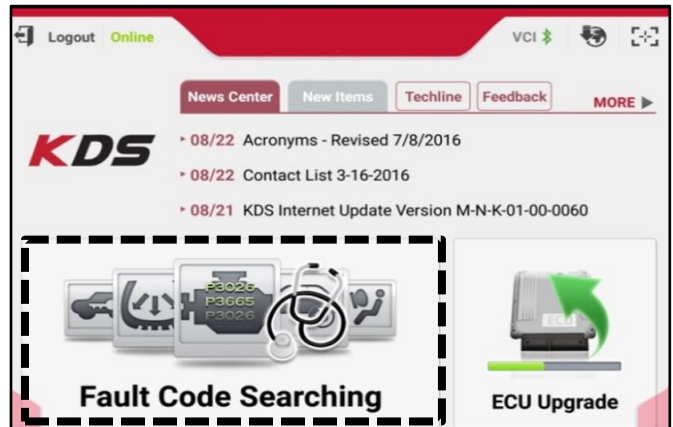
1. Verify no SRS airbag warning light is on. If it is on, perform a Fault Code Search with the KDS for any DTCs listed on page 1.
 - If the DTCs listed on page 1 are stored or active, proceed with the replacement procedure on page 4.
 - If the DTCs are not listed on page 1 but related to the SRS, further diagnosis is required and not covered in this bulletin. File a separate claim as necessary.
