GROUP Safety Recall Campaign	MODEL 2015-2018MY Sedona (YP)
	NUMBER SC175	DATE March 2019
SAFETY RECALL CAMPAIGN		
SUBJECT: FRONT PASSENGER SEAT OCCUPANT DETECTION SYSTEM (ODS) WIRING HARNESS (SC175)

FRONT PASSENGER SEAT OCCUPANT DETECTION SYSTEM (ODS) WIRING HARNESS (SC175)

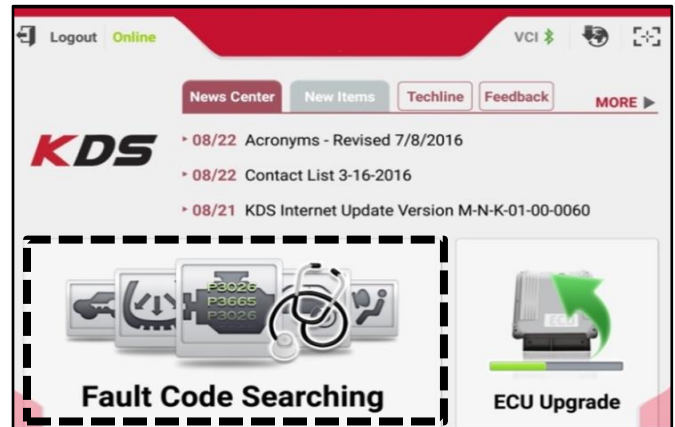
1. Verify no SRS airbag warning light is on. If it is on, perform a Fault Code Search with the KDS for any DTCs listed on page 1.
 - If the DTCs listed on page 1 are stored or active, proceed with the replacement procedure on page 4.
 - If the DTCs are not listed on page 1 but related to the SRS, further diagnosis is required and not covered in this bulletin. File a separate claim as necessary.
