GROUP
Safety Recall Campaign

MODEL
2012-2016MY
Soul (AM, PS)

NUMBER
SC176 (Rev 2, 05/31/2019)

SUBJECT: ENGINE CONTROL UNIT (ECU)
LOGIC IMPROVEMENT (SC176)

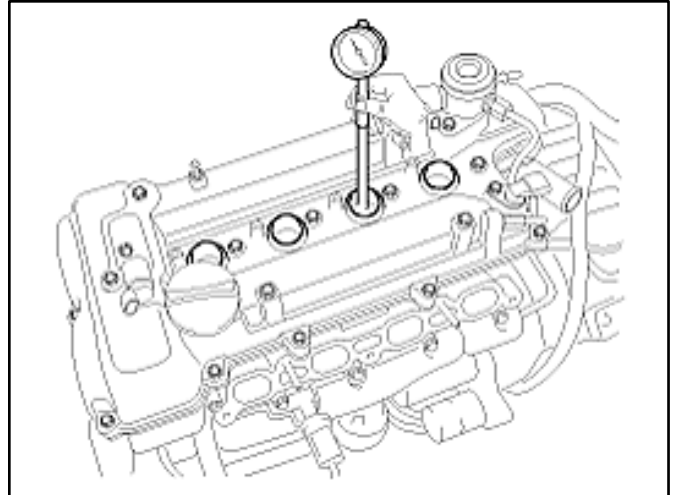
1. Ensure all conditions are met and then perform an engine compression check by referring to the “Engine Mechanical System → Compression Test” chapter in the applicable Shop Manual on KGIS.

- Coolant at operating temp (176°F)
- Battery fully charged
- If all cylinder compression results* are above the minimum specification, proceed to the Catalytic Converter Assembly Replacement Procedure below.
- If any cylinder compression result* is below the minimum specification, proceed to the Short Block Assembly Replacement Procedure on page 10.

Standard	178 PSI, 1225.83 KPa, 12.5 kg.cm ²
Minimum	149 PSI, 1029.69 KPa, 10.5 kg.cm ²

***Perform all cylinder compression checks twice (2x) and record both peak cranking values clearly and legibly on the repair order.**
