SERVICE PROCEDURE

19501

SUBJECT: SAFETY RECALL

Exhaust Hanger Bracket in certain 2016 thru 2020 International® LT® Series trucks built 15 December 2015 thru 08 February 2019 and certain 2017 and 2018 ProStar® model trucks built 02 March 2016 thru 12 June 2017 with 73-inch sleeper cab and feature code 07BKP or 07BKR (exhaust system with horizontal aftertreatment devise and horizontal tailpipe mounted on right-side).

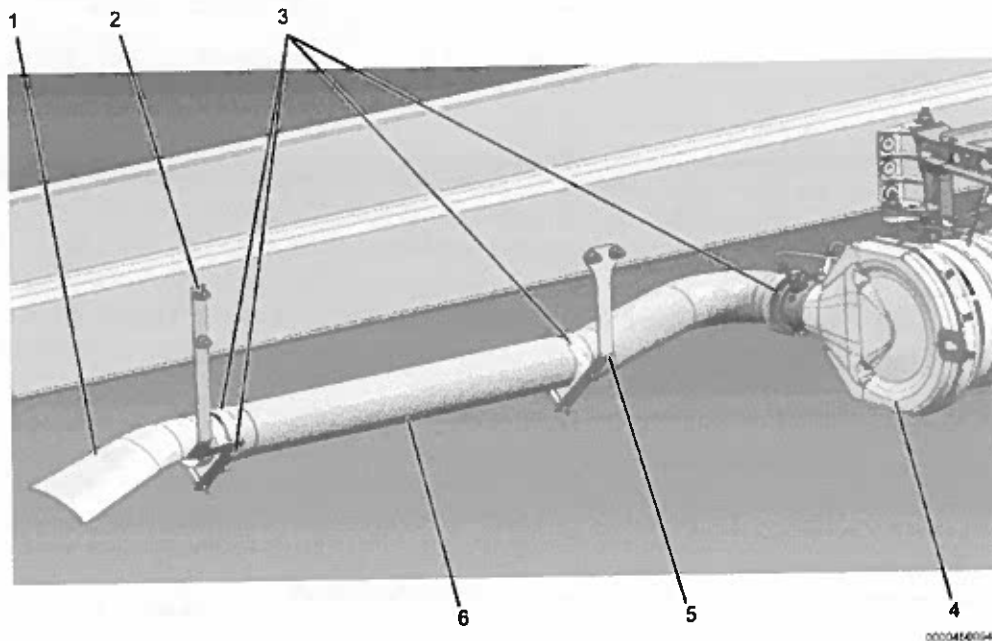
Figure 2. Exhaust System

The rear exhaust hanger bracket may crack and, over time, may cause the forward hanger bracket to crack and in some cases may result in partial or full separation of the exhaust tail pipe from the vehicle. If the exhaust tail pipe separates from the vehicle in operation, a loose part in the roadway could be struck by another vehicle which increases the risk of a vehicle crash.

5. Inspect exhaust tailpipe (Figure 2, Item 6) at Diesel Particulate Filter (DPF) (Figure 2, Item 4) for cracks.
 - a. If exhaust tailpipe has no cracks, proceed to Step 10.
 - b. If exhaust tailpipe has cracks, continue with Step 6.
6. Disconnect exhaust tailpipe from DPF and from rear hanger bracket (Figure 2, Item 2) and forward hanger bracket (Figure 2, Item 5). Save DPF clamp and clamp used at forward hanger bracket for reuse.
7. Remove diffuser (Figure 2, Item 1) from exhaust tailpipe. Save diffuser and clamp (Figure 2, Item 3) for reuse.

8. Using Marmon clamp or band clamp (Figure 2, Item 3), install diffuser (Figure 2, Item 1) onto new exhaust tailpipe (Figure 2, Item 4). Tighten Marmon clamp or band clamp to their specified torque.

9. Install new exhaust tailpipe (Figure 2, Item 6) onto DPF (Figure 2, Item 4). Do not tighten clamp at DPF (Figure 2, Item 3) at this time.
10. Remove rear hanger bracket (Figure 2, Item 2) from frame and save fasteners for reuse.

11. Remove clamp (Figure 2, Item 3) and rear hanger bracket (Figure 2, Item 2) at diffuser (Figure 1, Item 1) and discard.
12. Install new rear hanger bracket (Figure 2, Item 2) to frame. Tighten fasteners to 148 lb-ft (200 N.m).

13. Install new clamp (Figure 2, Item 3) and rear hanger bracket (Figure 2, Item 2) at diffuser (Figure 1, Item 1). Do not tighten clamp at this time.
14. Inspect forward hanger bracket (Figure 2, Item 5) for cracks.

- a. If bracket has no cracks, proceed to Step 19.
 - b. If bracket has cracks, continue with Step 15.
15. Remove forward hanger bracket (Figure 2, Item 5) from frame and save fasteners for reuse.

17. Install new forward hanger bracket (Figure 2, Item 5) to frame. Tighten fasteners to 148 lb-ft (200 N•m).
18. Reinstall clamp (Figure 2, Item 3) around exhaust tailpipe at forward hanger bracket (Figure 2, Item 5). Do not tighten clamp at this time.
19. Tighten clamps (Figure 2, Item 3) at forward hanger bracket (Figure 2, Item 5) and rear hanger bracket (Figure 2, Item 2). Tighten both clamps to 195 - 247 lb-in (22 - 28 N•m).
20. If pipe was replaced, tighten clamp at DPF (Figure 2, Item 3) to 89 – 133 lb-in (10 - 15 N•m).
21. Remove wheel chocks.
