Revised March 2019

Dealer Service Instructions for:

Safety Recall V17 / NHTSA 19V-142 48-Volt Ground Cable Fastener

2019 (DT) 1500 RAM

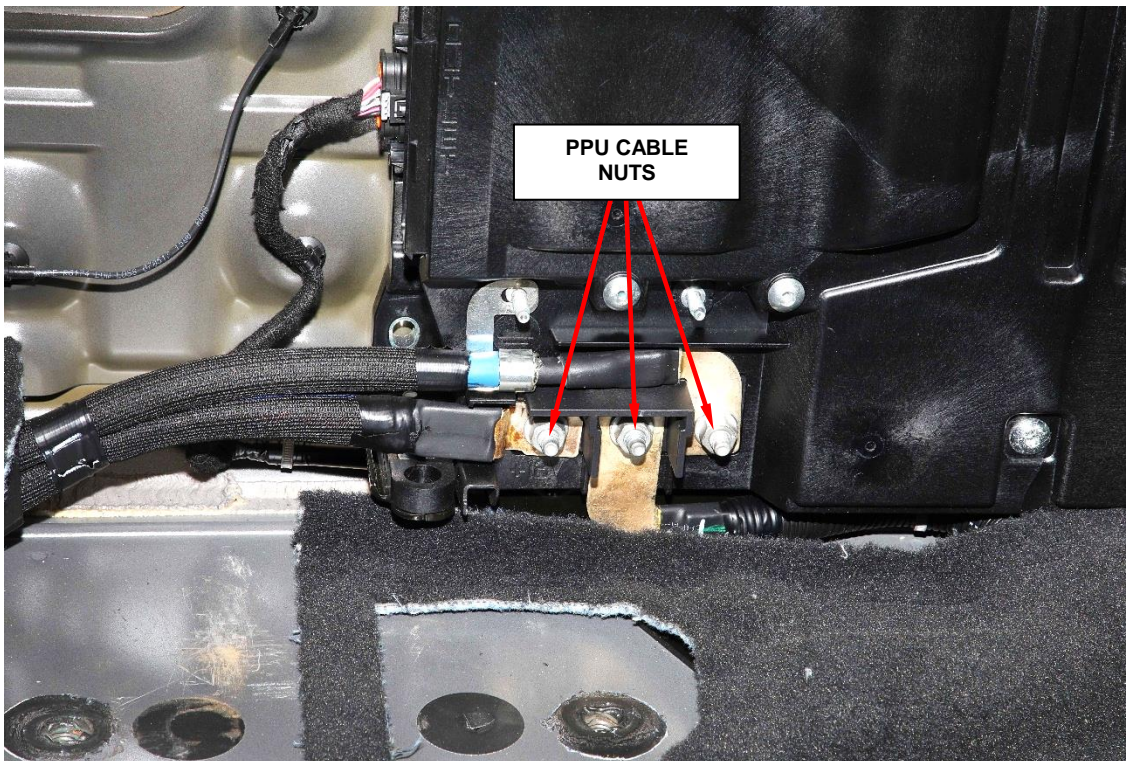
Figure 10 – PPU Connections

The 48-Volt auxiliary battery on about 33 of the above vehicles may have been built with a loose terminal connection at the 48-Volt auxiliary battery cable. This condition can cause localized heating at the cable terminal connection located behind the rear seat. Continuous heating at the cable terminal can propagate into an interior vehicle fire with the ignition on or off. **An interior vehicle fire may lead to an increased risk of injury to occupants and persons outside the vehicle, and property damage as well.**

NOTE: If there is visible discoloration on the cable eyelets, studs or proper torque is not achievable, please contact the STAR Center for direction on how to proceed with repair.

Inspect the 48-Volt Power Pack Unit (PPU) cable nuts for proper torque, and tighten to 20 N·m (15ft. lbs.) if loose.

- Using a torque wrench tighten all the PPU cable nuts to 20 N·m (15ft. lbs.). (Figure 10).
