March 2019

Dealer Service Instructions for:

Safety Recall V17 / NHTSA 19V-142 48-Volt Ground Cable Fastener

2019 (DT) 1500 RAM

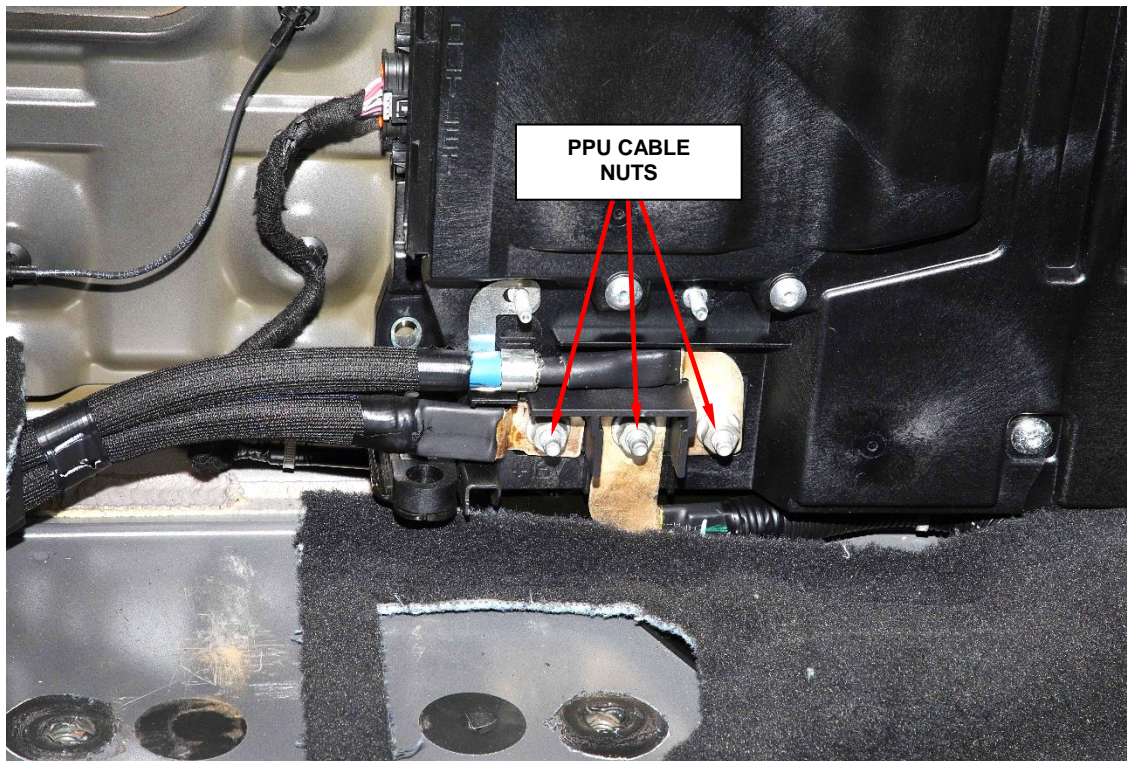
Figure 10 – PPU Connections

The 48-Volt auxiliary battery on about 33 of the above vehicles may have been built with a loose terminal connection at the 48-Volt auxiliary battery cable. This condition can cause localized heating at the cable terminal connection located behind the rear seat. Continuous heating at the cable terminal can propagate into an interior vehicle fire with the ignition on or off. **An interior vehicle fire may lead to an increased risk of injury to occupants and persons outside the vehicle, and property damage as well.**

NOTE: If there is visible discoloration on the cable eyelets, studs or proper torque is not achievable, please contact the STAR Center for direction on how to proceed with repair.

Inspect the 48-Volt Power Pack Unit (PPU) cable nuts for proper torque, and tighten to 20 N·m (15ft. lbs.) if loose.

- Using a torque wrench tighten all the PPU cable nuts to 20 N·m (15ft. lbs.). (Figure 10).
