PRODUCT CAMPAIGN BULLETIN

APPLICABILITY: 2013-2017 Crosstrek
 2014-2016 Forester
 2008-2016 Impreza 4-door
 2012-2016 Impreza 5-door
 2008-2014 WRX 4-door

NUMBER: WUE-90R
NHTSA ID: 19V-149
DATE: 04/09/19
REVISED: 04/24/19

SUBJECT: Brake Lamp Switch Replacement

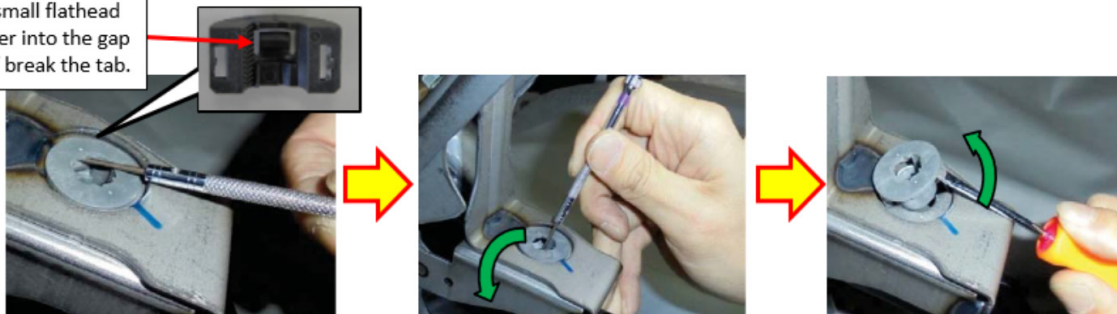
Insert a small flathead screwdriver into the gap then pry / break the tab.

- 3) Wearing appropriate eye protection and using a small flat-blade screw driver, pry and break one of the 2 retaining tabs securing the plastic clip to the pedal bracket. Use a larger flat-blade screw driver to pry the remainder of the clip loose. Make sure any remaining broken pieces are removed from the vehicle.

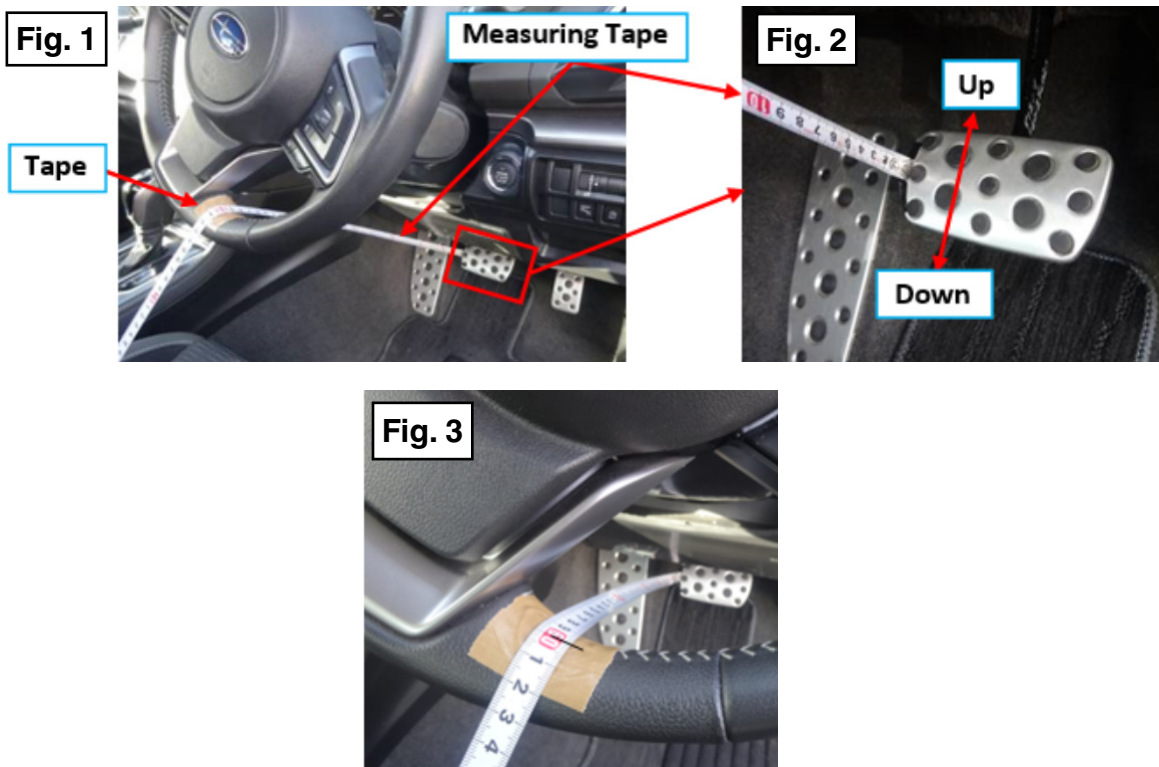
The pedal stroke specification for these models is 4mm to 6mm.

- “Hook” the end of a tape measure to the end of the brake pedal as shown below. **NOTE:** The up-down position (**Fig. 2**, blue line) of the tape measure on the brake pedal is critical for making consistent measurements.

- **SLOWLY** depress the brake pedal until the brake lights illuminate. Measure the brake pedal stroke (distance from “free” position to stop light ON position) following the reference pictures below.

- If the measurement is within the standard value (4 mm - 6 mm), proceed to **11**) below and secure the conversion harness as described in **12**) below.
- If the measurement is out of standard value (less than 4 mm or more than 6 mm), repeat this step and **CAREFULLY** re-adjust the brake lamp switch position as necessary to achieve the standard value.
