GROUP Safety Recall Campaign	MODEL 2019MY Sedona (YP)
	NUMBER SC177	DATE April 2019
SAFETY RECALL CAMPAIGN		
SUBJECT: 2ND ROW CENTER SEAT BELT BUCKLE (SC177)

This bulletin provides the procedure to inspect and, if necessary, reinstall the second row middle seat belt buckles on certain 2019MY Sedona (YP) vehicles equipped with an 8-passenger seat configuration manufactured from October 31, 2018 through November 28, 2018. The recalled vehicles may not comply with the FMVSS No. 208 (Occupant Crash Protection) requirements that each rear designated seating position contain a functioning Type 2 (or 3-point) seat belt assembly. The seat belt buckles for the second-row middle seat may have been installed on the wrong side of the seat, preventing proper use of the 3-point seat belt. An incorrectly used seat belt can increase the risk of injury in a crash. Before conducting the procedure, verify the vehicle is included in the list of affected VINs.

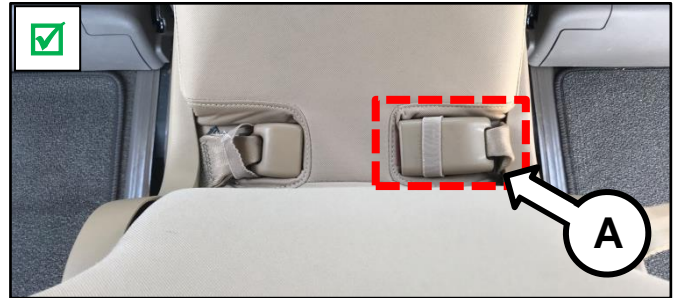
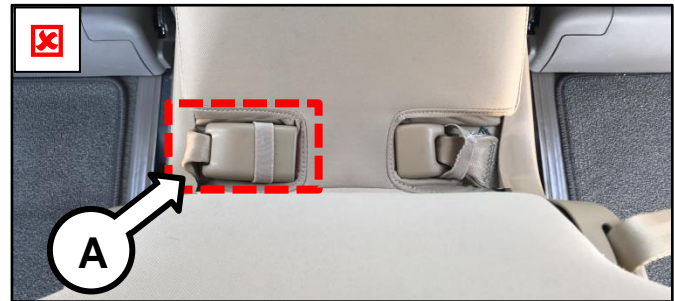
1. While sitting in the 2nd row center seat, locate the center seat belt buckle (A).
 - If the 2nd row center seat belt buckle is located on the right side of the center seat (✓), no further action is required.
 - If the 2nd row center seat belt buckle is located on the left of the center seat (✗), proceed to the Center Seat Belt Buckle Reinstallation Procedure below.

**Center Seat Belt Buckle Reinstallation Procedure:**
