Service Bulletin

19-046

Safety Recall: 2018-19 Odyssey Check Park Mechanism, Battery Terminal Inspection, and Update TCM

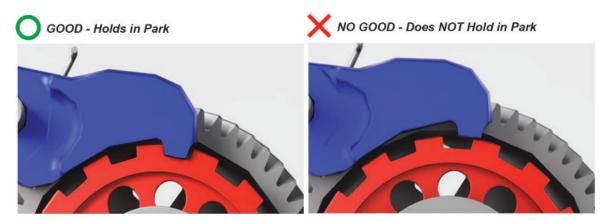
A momentary voltage loss to the TCM, usually caused by a loose battery terminal, can cause the transmission to shift to Park while driving. When this happens, the parking mechanism could get damaged, and the vehicle may move while the shifter is in Park.

The blue component is the park pawl; the red component is the park gear.

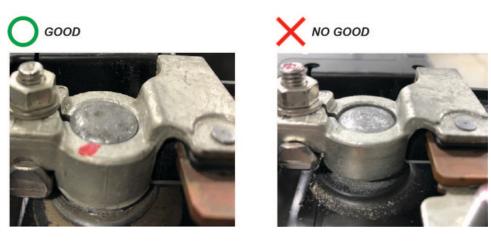
3. Compare both battery terminals to the examples below.

Do the battery terminals look like the good example?

Yes - Go to step 4.

No - Go to TERMINAL REPAIR.

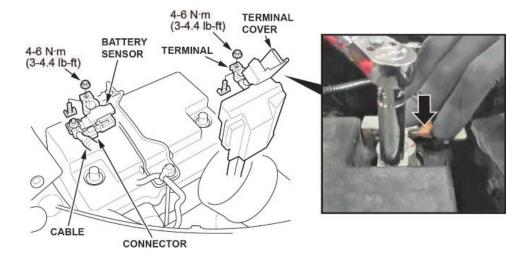
- Do not over torque the terminal.
- · Always connect the positive side first.

2. While holding down the terminal, torque both positive and negative clamps to 4-6 N•m (35-53 lb-in).

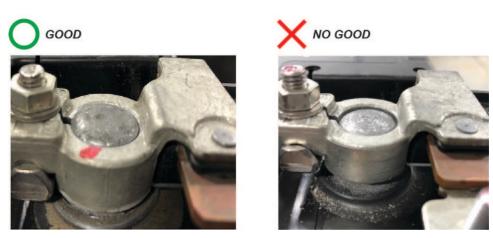
7. Compare both of the battery terminals to the examples below.

Do the battery terminals look like the good example?

Yes - Go to step 9.

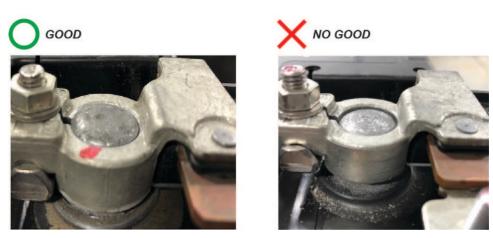
3. Compare both of the battery terminals to the examples below.

Do the battery terminals look like the good example?

Yes - Go to step 4.

No - Go to REPLACE BATTERY TERMINAL.
