RECALL CAMPAIGN BULLETIN

| FE19-005 | NTB19-035 | April 18, 2019 |

VOLUNTARY RECALL CAMPAIGN 2019 ALTIMA FUEL PUMP LOCK RING INSPECTION

CAMPAIGN ID #: PC692
APPLIED VEHICLES: 2019 Altima (L34)
APPLIED ENGINE: PR25DD
APPLIED DRIVETRAIN: FWD only

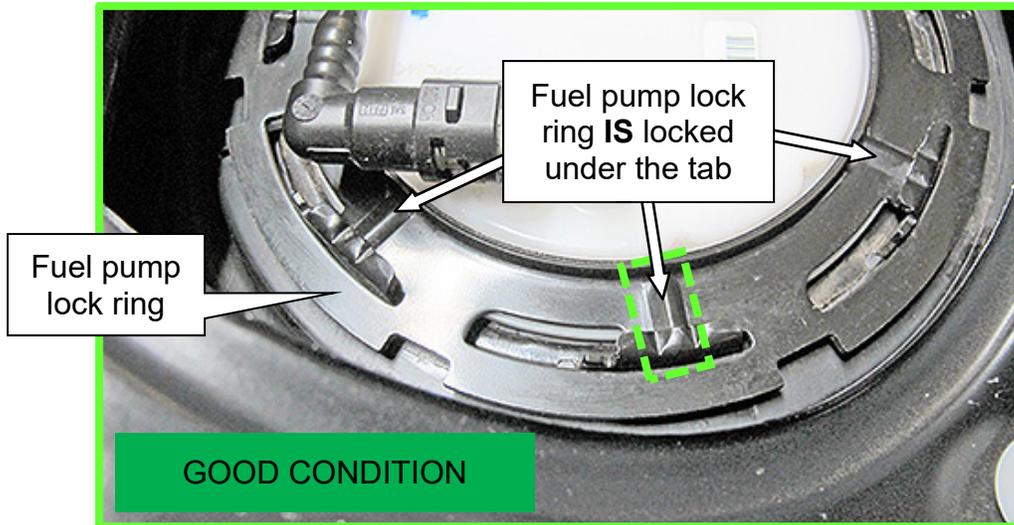
7. Inspect the fuel pump lock ring.
 - Is the lock ring correctly locked in place as shown in Figure 7 on page 5?
YES: Skip to step 10 on page 7.
NO:
 - If the lock ring is still engaged, but not locked as shown in Figure 8, proceed to step 8 on page 6.
 - If the fuel pump is disengaged (loose) as shown in Figure 9, replace the fuel pump assembly and O-ring, and then proceed to step 12 on page 8.
 - Refer to the Electronic Service Manual (ESM) for the procedure to replace the fuel level sensor unit and fuel pump: **REPAIR > ENGINE > FUEL SYSTEM > REMOVAL AND INSTALLATION > FUEL LEVEL SENSOR UNIT, FUEL FILTER AND FUEL PUMP ASSEMBLY.**

9. Using tool J-45722 (Figure 11), rotate the fuel pump lock ring clockwise to lock (Figure 12).
- Verify fuel pump lock ring is locked to the fuel tank (see Figure 7).
